Assessment report Historical Building Turkish Cultural center Wazeriyah – Baghdad – Iraq

Date of visit 26-1-2024

Prof. Dr. Mahmood Khayat

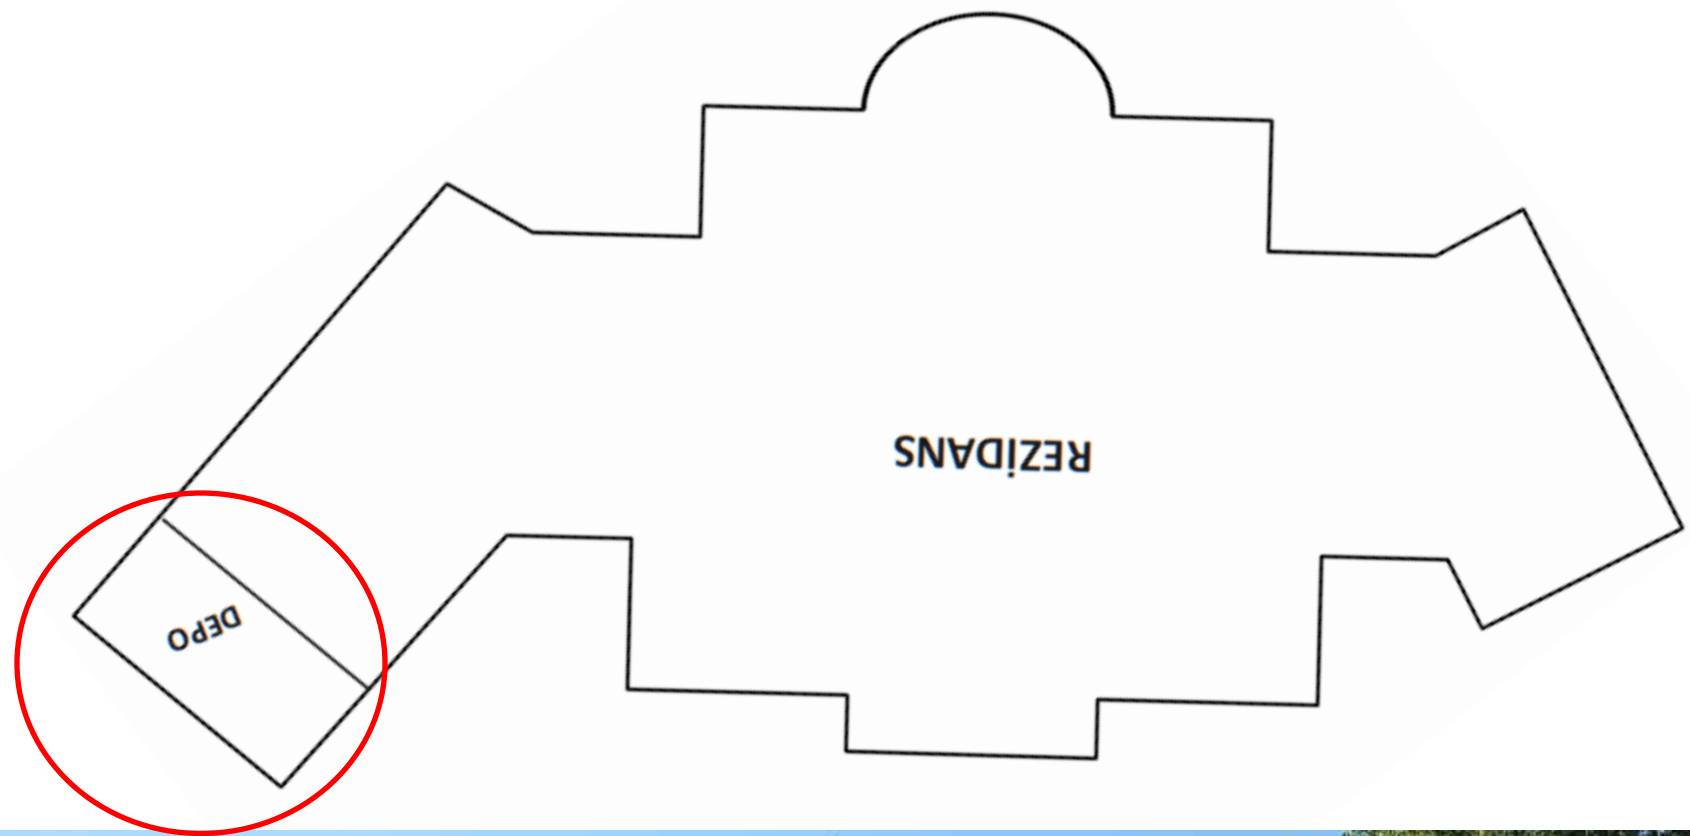
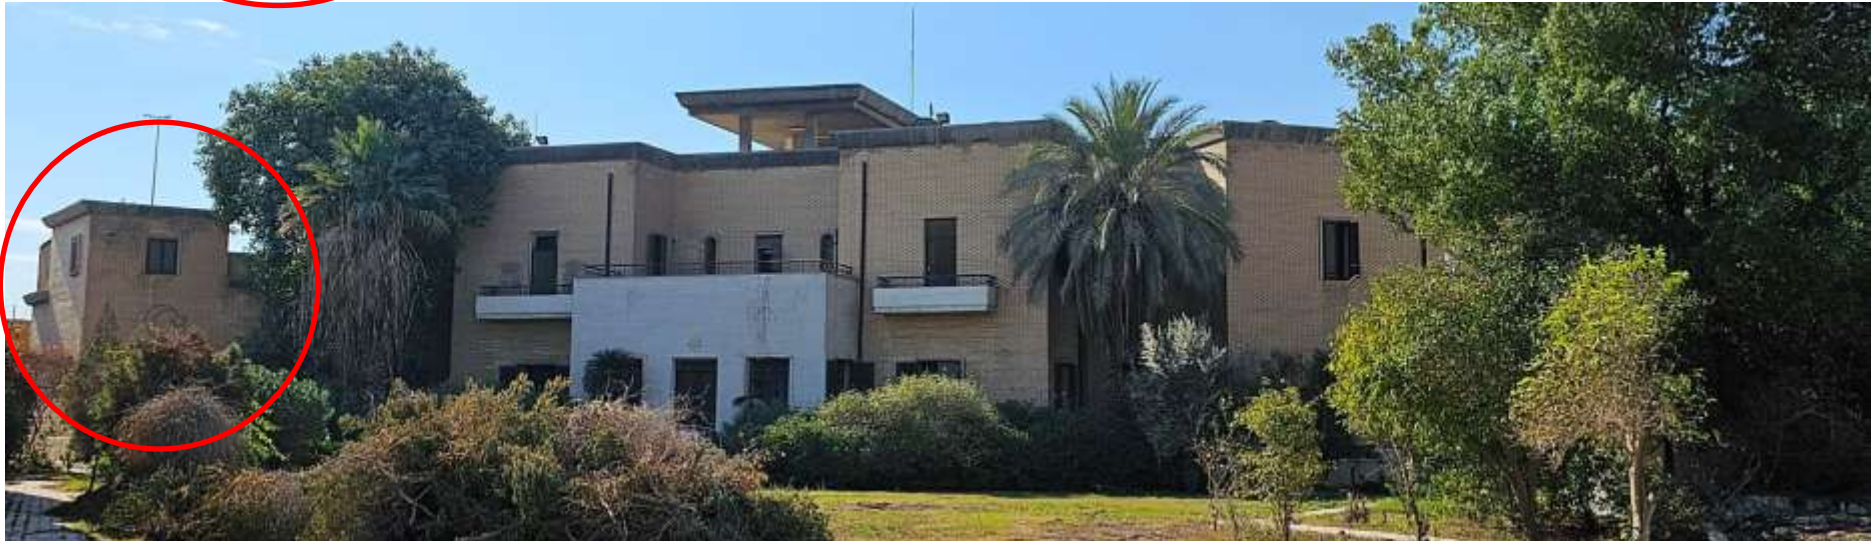
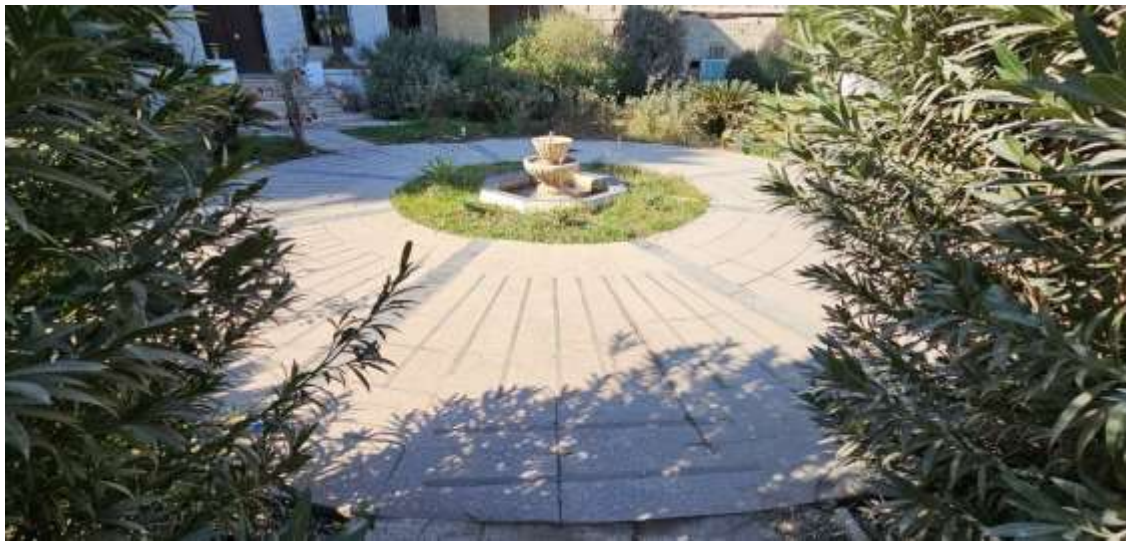
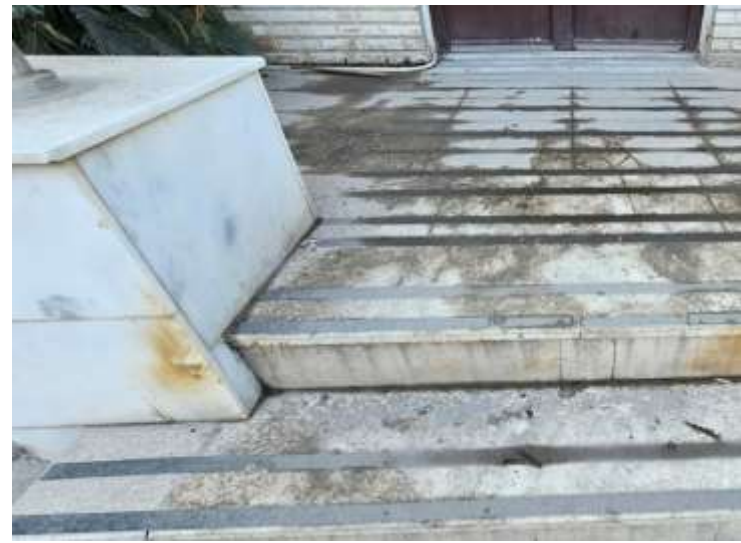
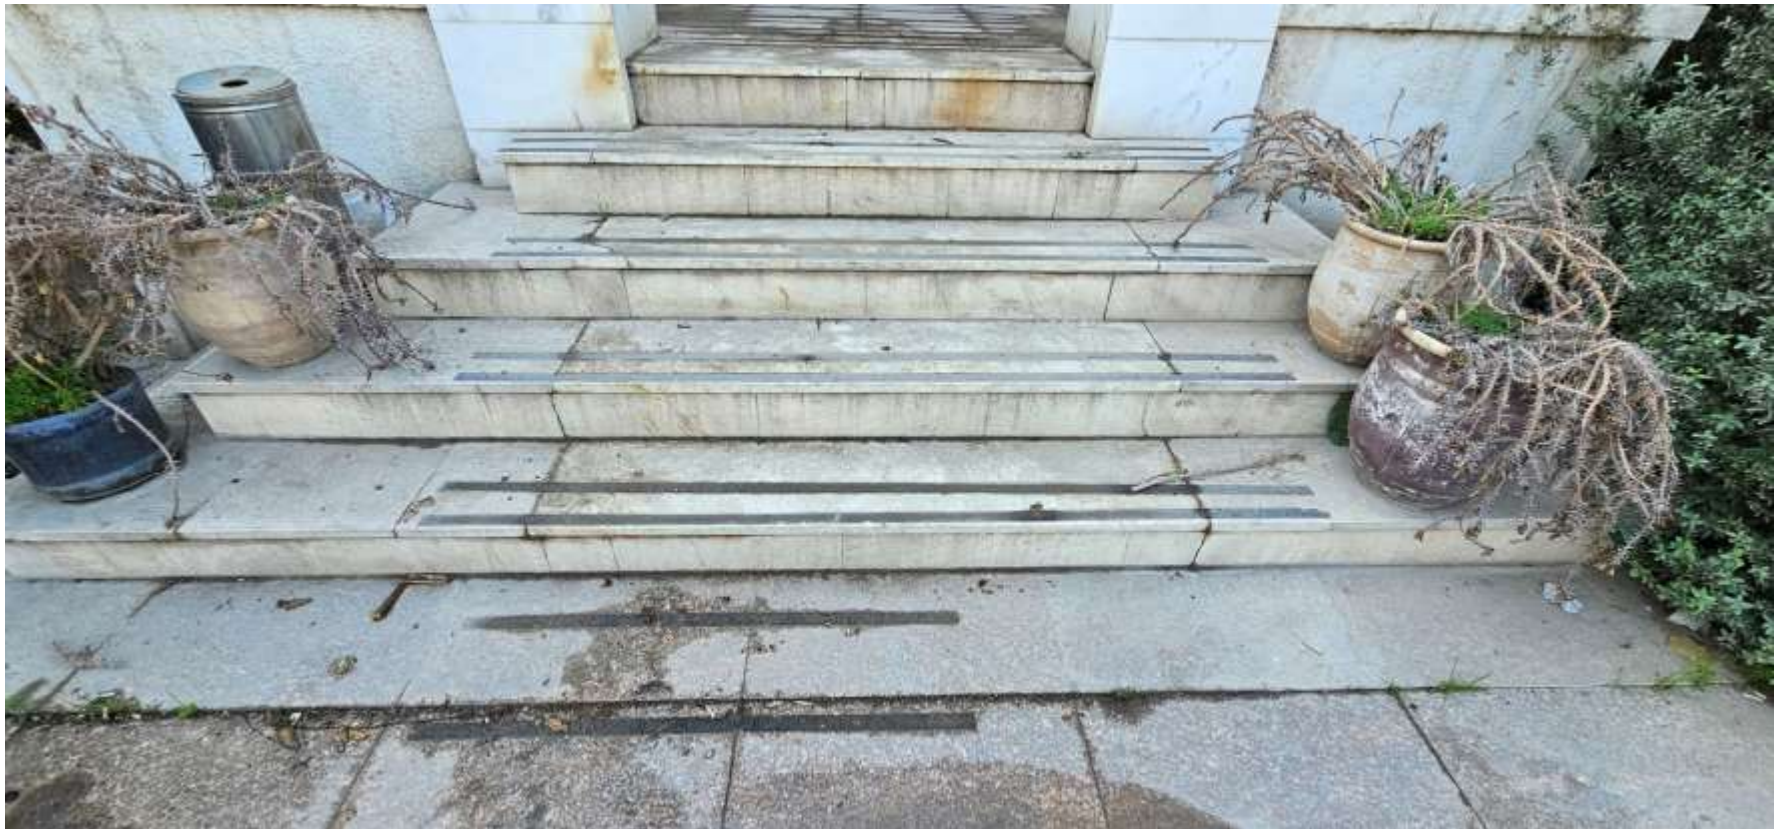
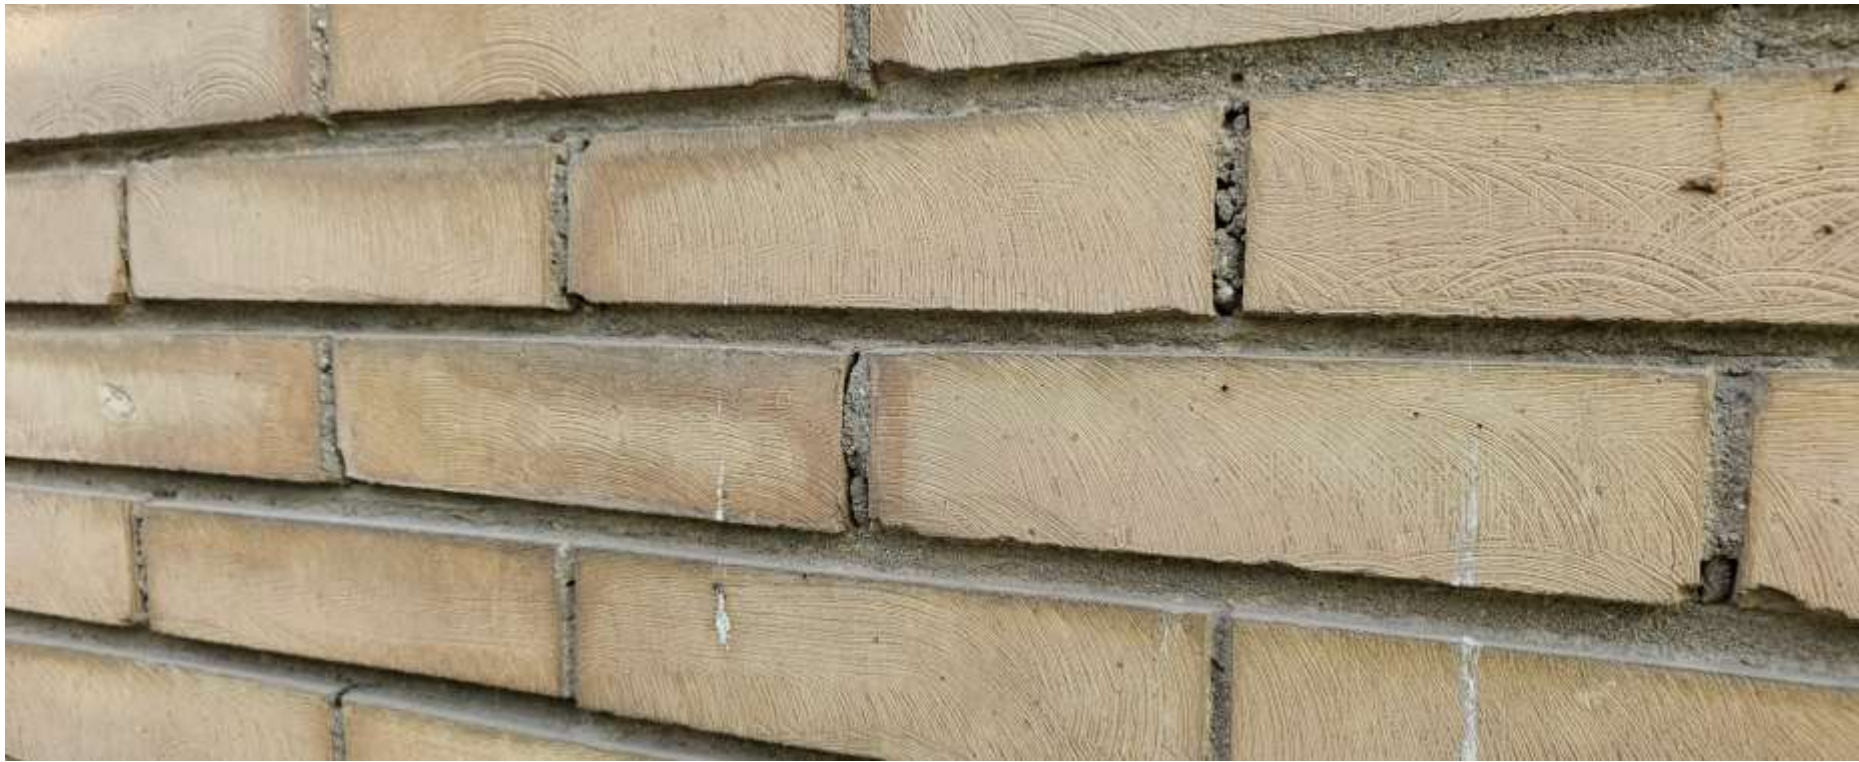
1-1-1- Façade 1

The main entrance mass is in the middle of façade 1, it is painted in white, it seems that due to seasoning and weathering the color of the brick was changed, this led to the decision of painting this part of the façade by white emulsion paint.

The entrance is raised by 3 steps, these steps are made of Turkish Marble, mostly Diyarbakir or Mugla beige, the flower beds are covered with Gray White Turkish marble most probably Afyon it is clear that the marble was added in the late 1980s or later because the traces of corrosion of the steel clamps are clear as orange stain on the face of the marble.

It is recommended to use:
Water jet wash
No grinding
Same color paint

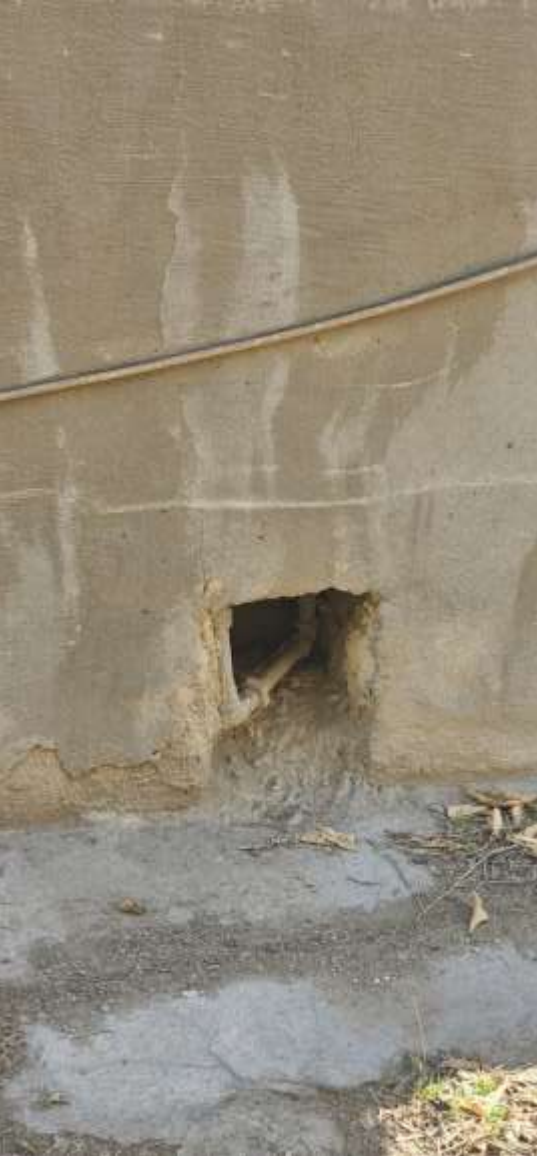
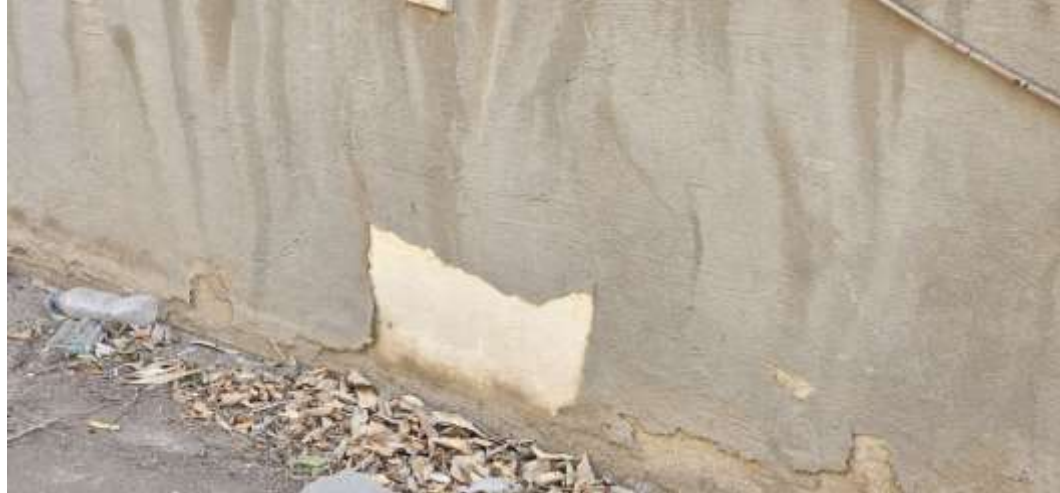
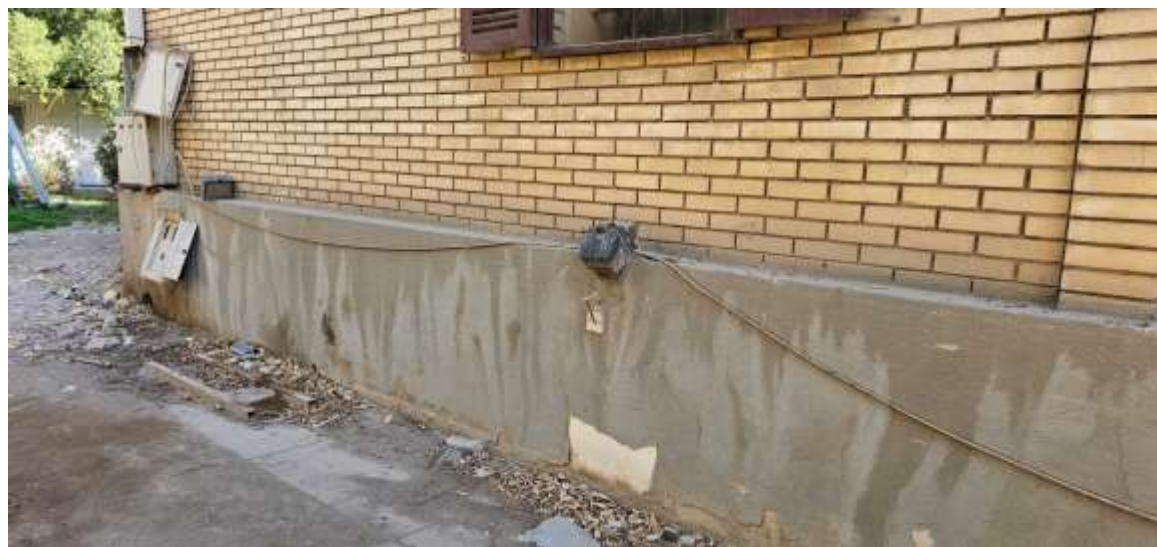
1-1-2- Façade 2

The side façade 2 is a high blank wall with few openings some new steel and plastic pipes can be noticed it is clear they were added later after the facing period, the old pipes before the time of facing with brick were covered by brick, and they can be noticed as vertical stacks on the façade

The exposed pipes at the facades can be hidden by covering with brick, the same dimension and color 2cm thick facing brick that can be found in the local market, it can be fixed on a layer of hey rib or cement board.

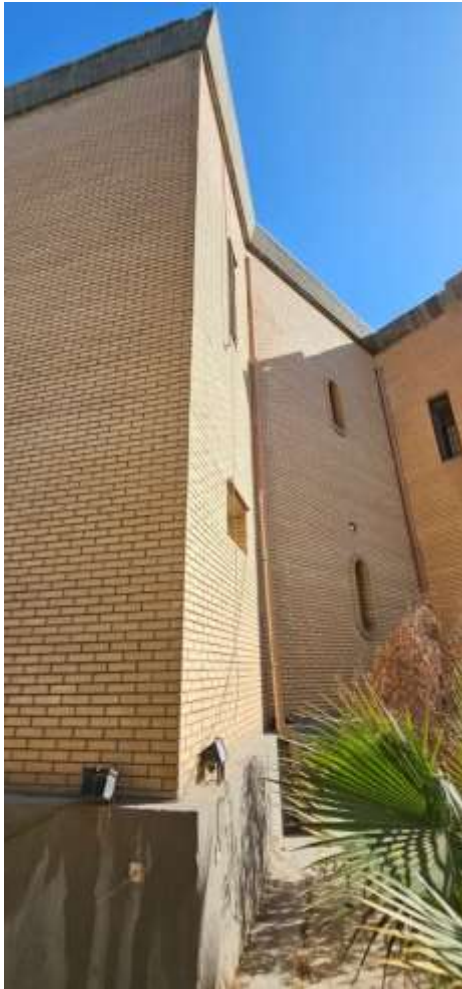
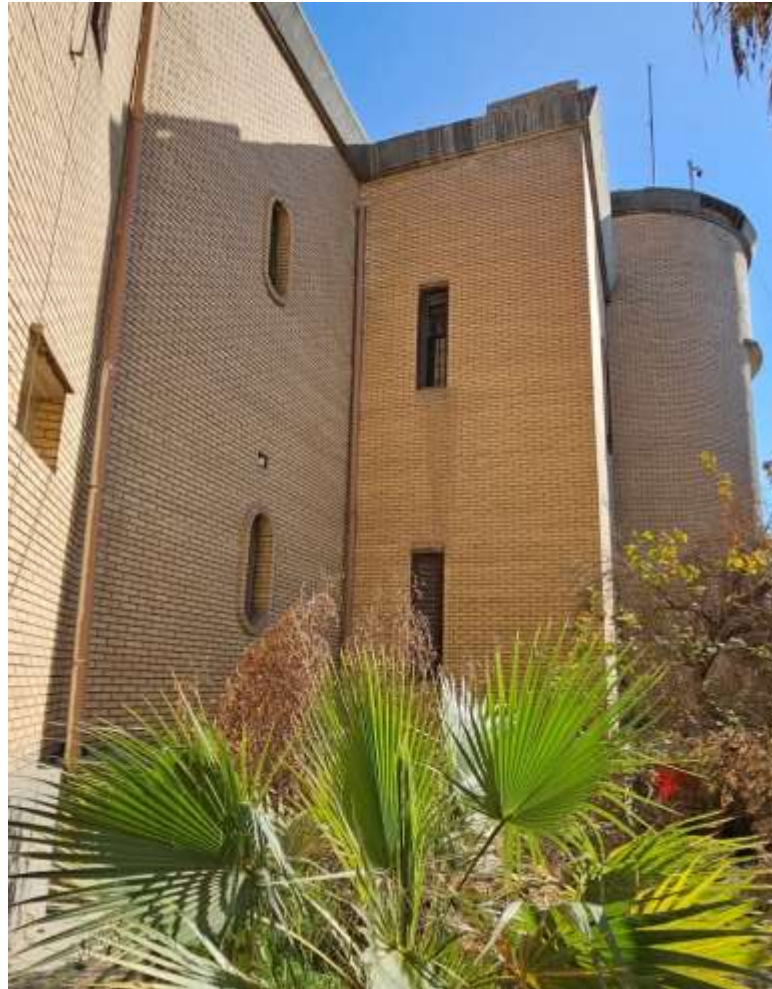
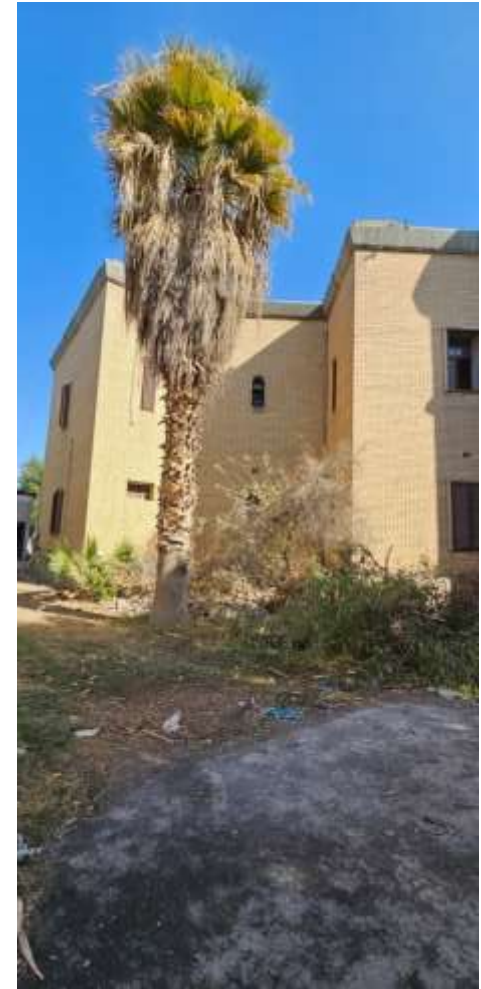
1-1-3- façade 3

The rare entrance is in the middle of the façade number 3, some hair cracks can be noticed in the brick facing wall, it is very clear that this façade was neglected and was used for services and there is an additional mass that locks it was added later for servants and guards but still before the time of the brick facing, even the Brick facing details in this part looks poor.

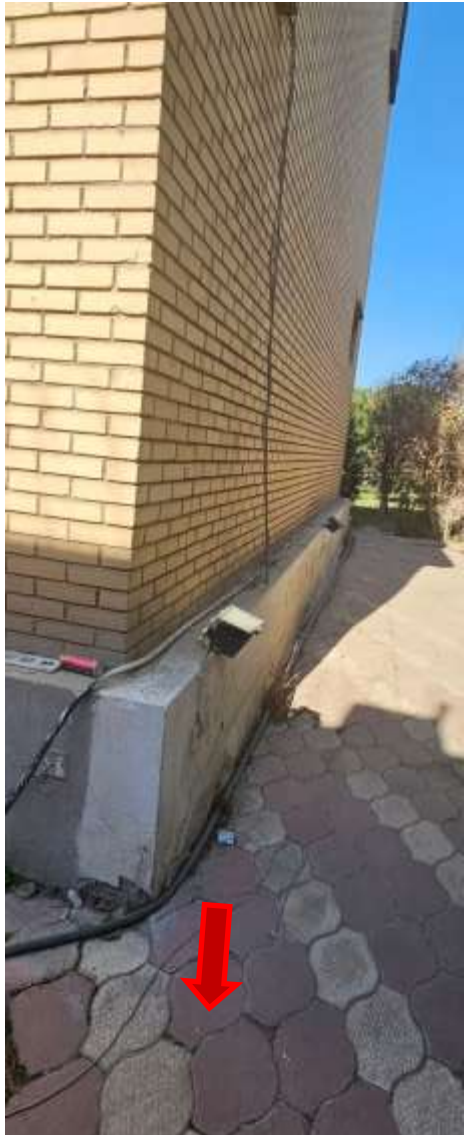
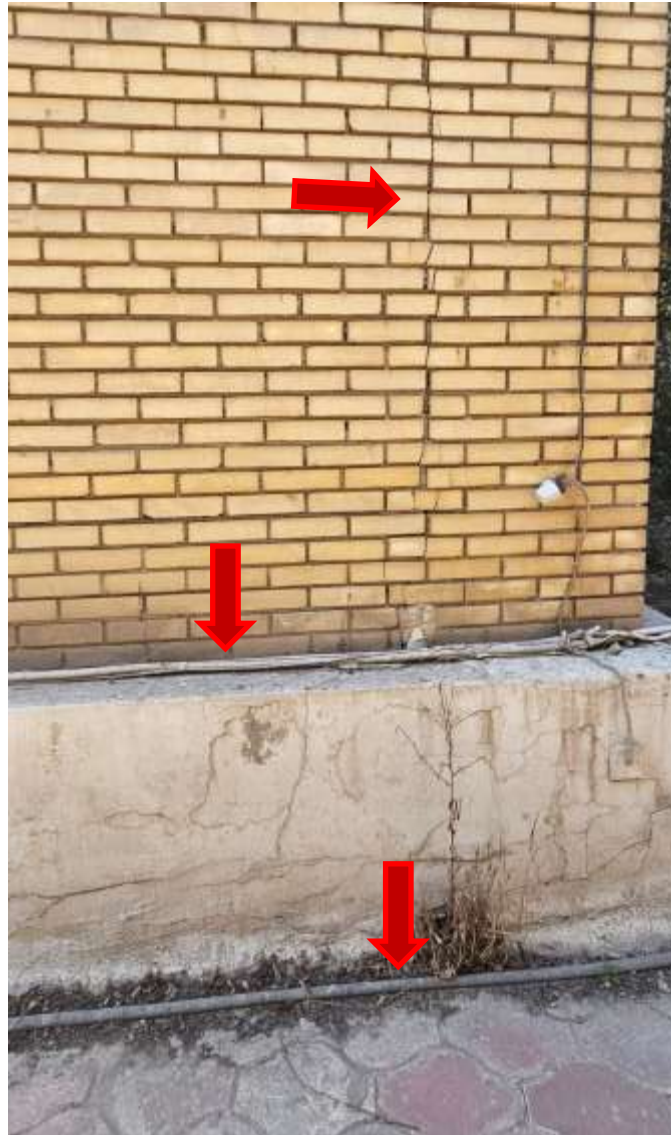
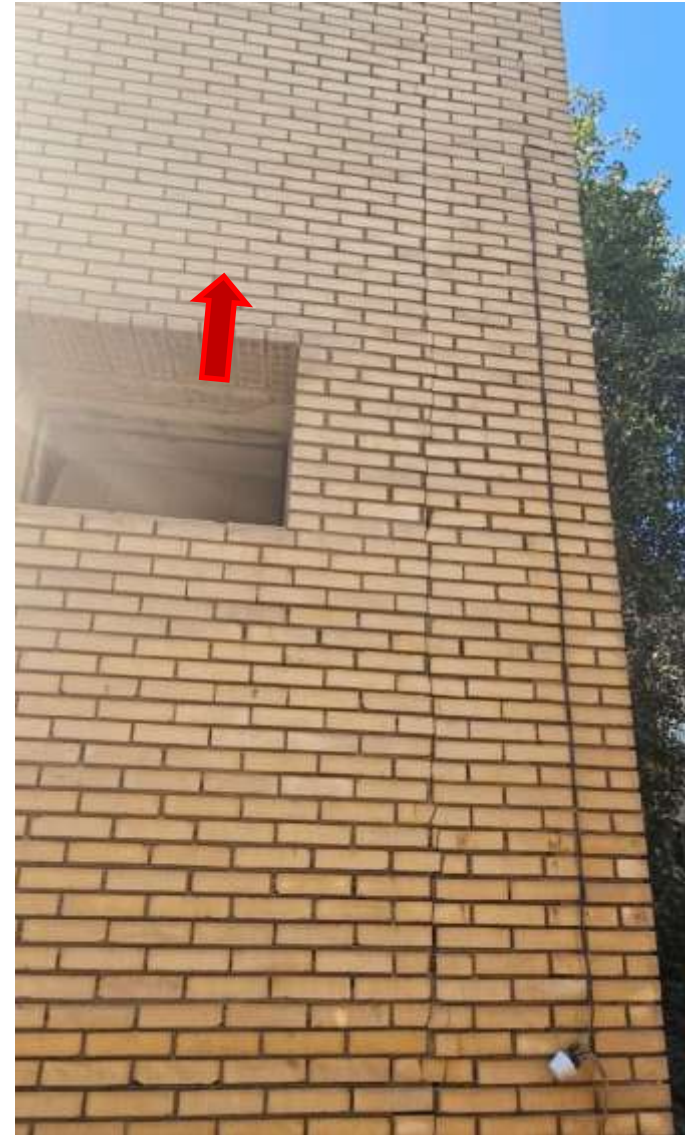
1-1-4-Façade 4

Façade number 4 covers the side facade of the main building and what can be seen is a high wall of a separated structure of the garage and the service area and the kitchen, a vertical hair crack can be noticed in the brick facing wall.

It is clear that the façade wall was constructed in a later stage at the late 1980s or early 1990s, the size of this brick is smaller than standard brick used for construction in Iraq, it is 6x20x10cm, no serious cracks were detected in this facing wall other than one at façade no. 4 that is continuous from the ground till the parapet

The major structural defect in the façade brick is the one at façade 4 where a continuous from the ground to the parapet crack can be noticed, the can be treated by injecting special grout using fine anchoring nails.

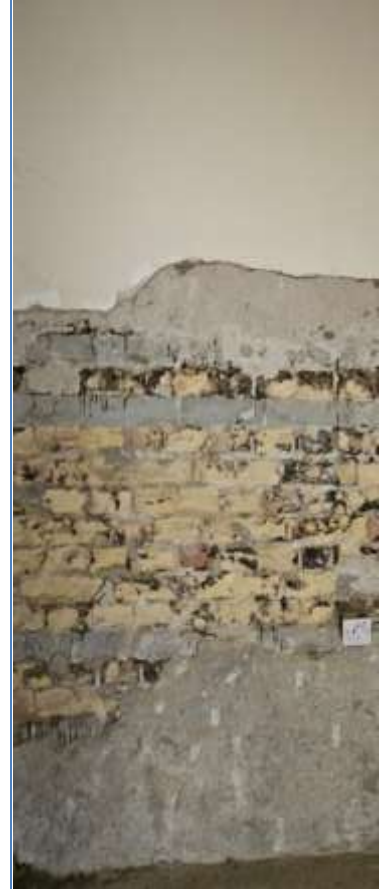
1-3-1-Foundation

The foundation is a strip type with staggered brickwork base until reaching the width of 48cm which is the width of the walls, at one of the inspection pits a concrete damp proof course can be noticed, this layer is called locally (PADLO), it is a plain concrete layer where sulfates salts resistant cement is used in addition to adding porosity reduction agent (called locally SIKA) in the other pit, this layer was not was not visible, in other walls where the interior layer was stripped of the use of 2 types of brick was noticed the yellow (backed clay) brick and a grey one (most probably sand brick which was available at the time of construction, this type of brick is known for determining damp movement within the structure .

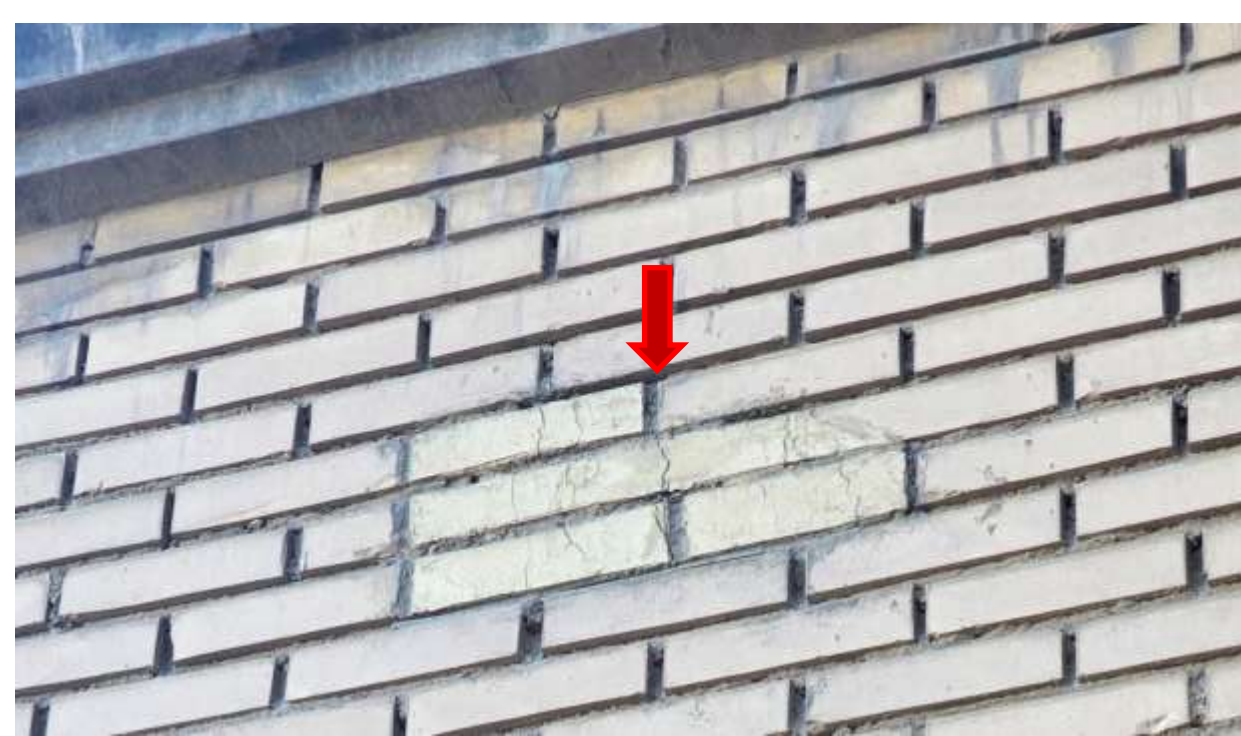
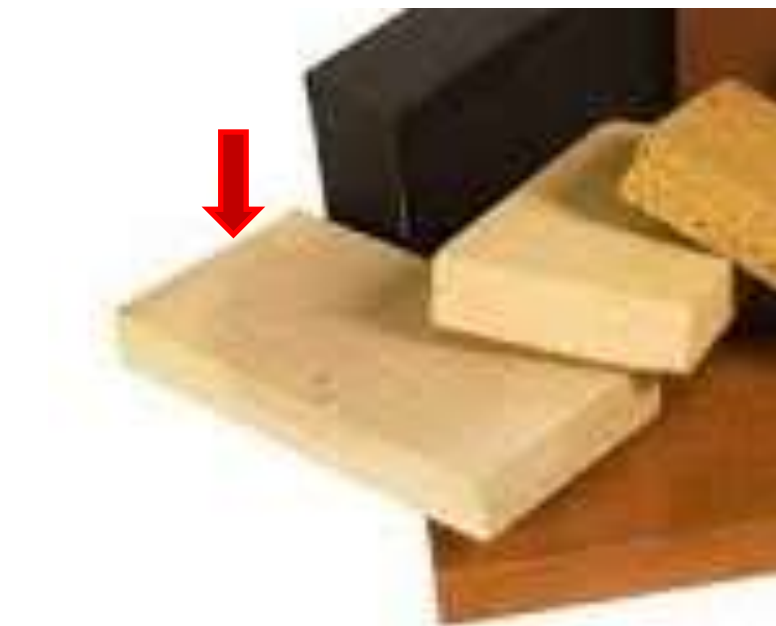
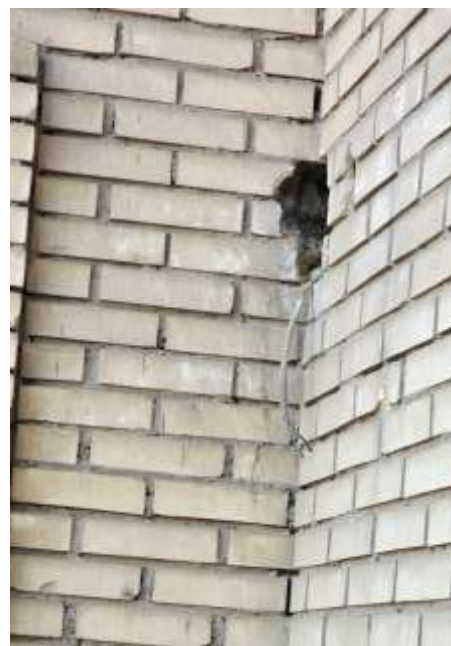
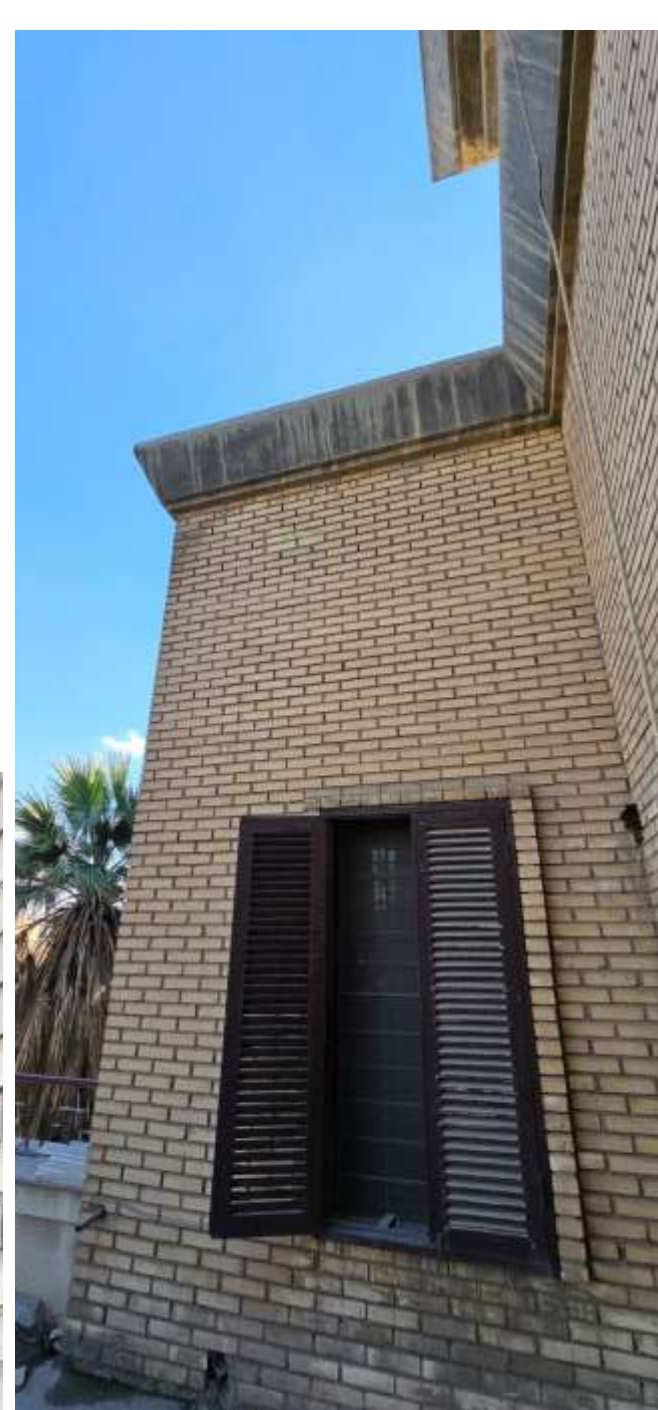
2-1- Façade brick

The major architecture defect is the change of color because of weathering, it is not recommended to use any chemical material or grinding, it is recommended to use special detergents and rinsing with under pressure water.

Many missing brick pieces in various locations can be noticed, these pieces can be replaced using the same dimension and color 2cm thick facing brick that can be found in the local market.

Mall brick maintenance was noticed, it was in the central balcony on top of the main entrance where the missing pieces of brick were replaced with cement mortar filling then it was painted in yellow the same color of the façade brick.

The painted in white area can be easily rinsed with under pressure water, then it can be painted with emulsion paint with a color similar to the yellow brick color

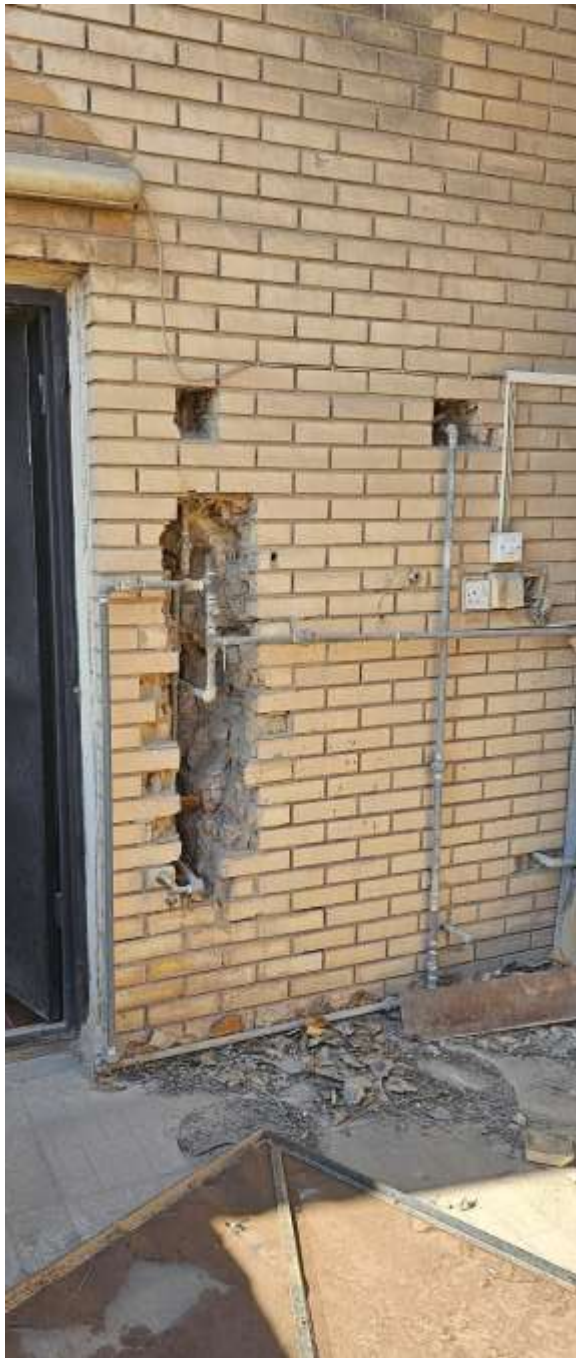
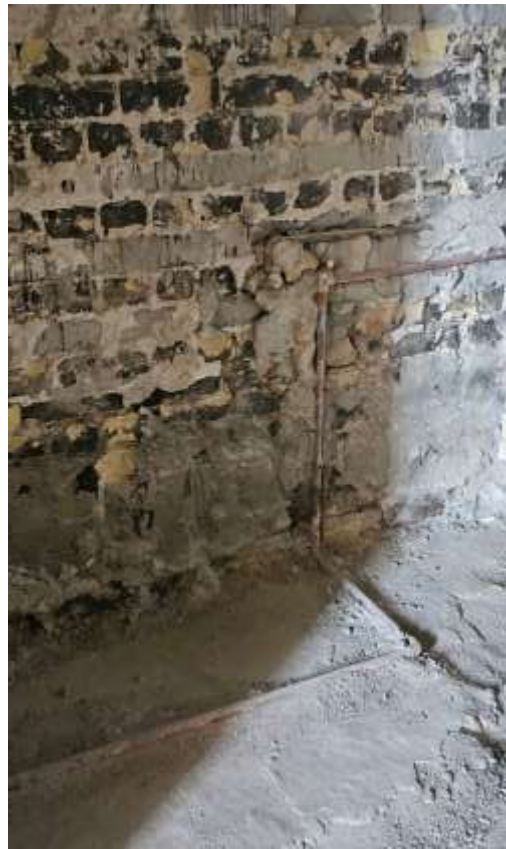
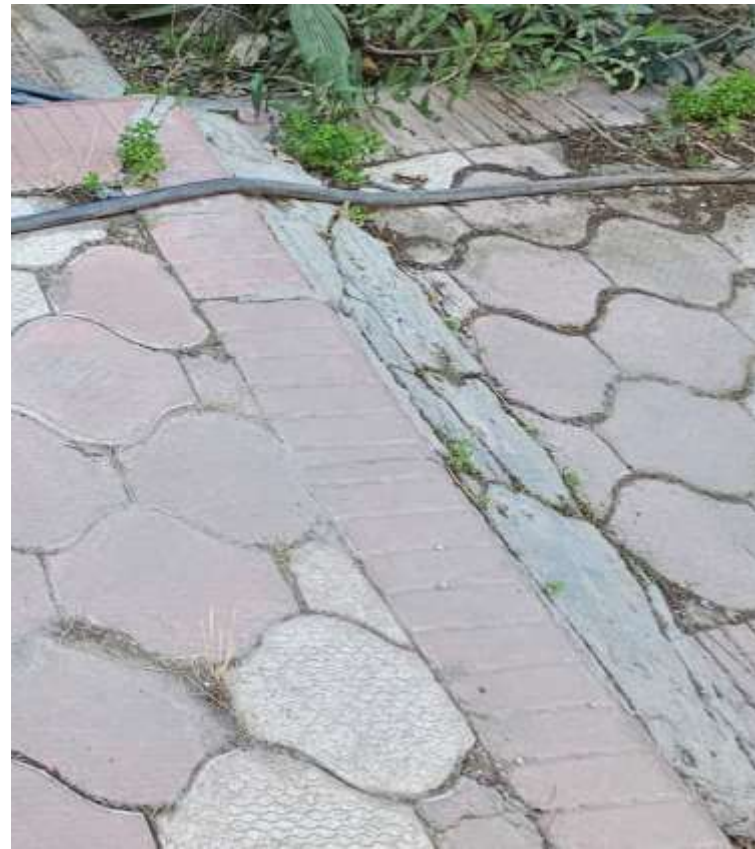
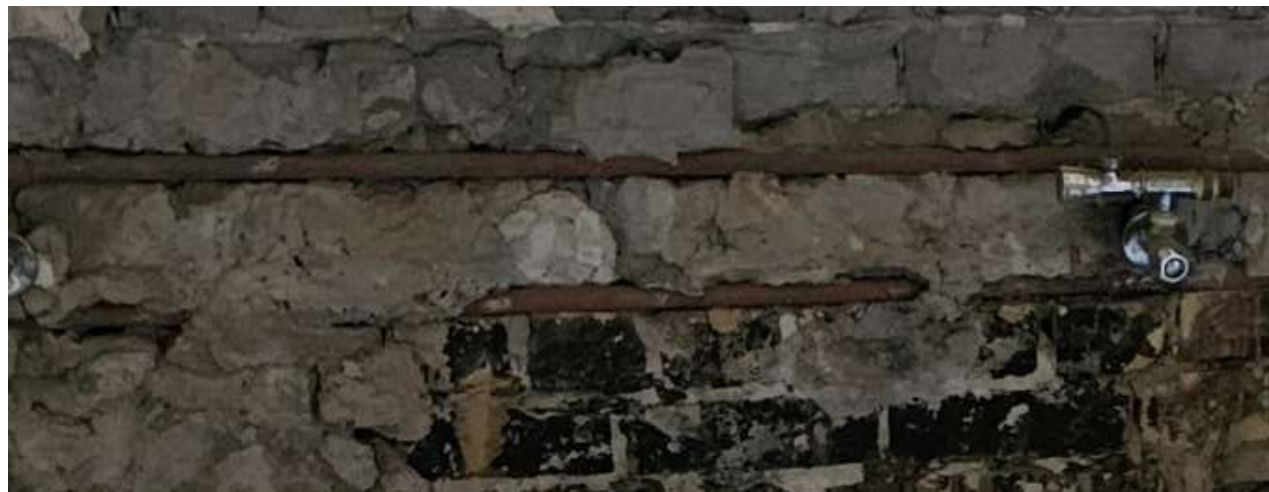
2-3- Water supply and sanitation

It was noticed that there were many changes in the water supply and sanitation network, and it is assumed that all will be replaced taking into consideration the following

- All exposed pipes to be galvanized steel pipes that can stand Baghdad hot whether
- All covered pipes can be PPR ones
- It is recommended not to lay any water supply pipe under flooring tiles it can be suspended between the slab and the existing false ceiling
- In case it is needed to cross the walls it is recommended to use the already existing pipe outlet, the old unused pipes can easily be removed and replaced with new ones at the same opening and prevent making new openings and causing less damage to the structure.
- It is recommended to remove all the layer that covers the first floor slab at the wet areas and in case an opening in the slab is required it has to be by removing a piece of brick and be away of the steel I beams.

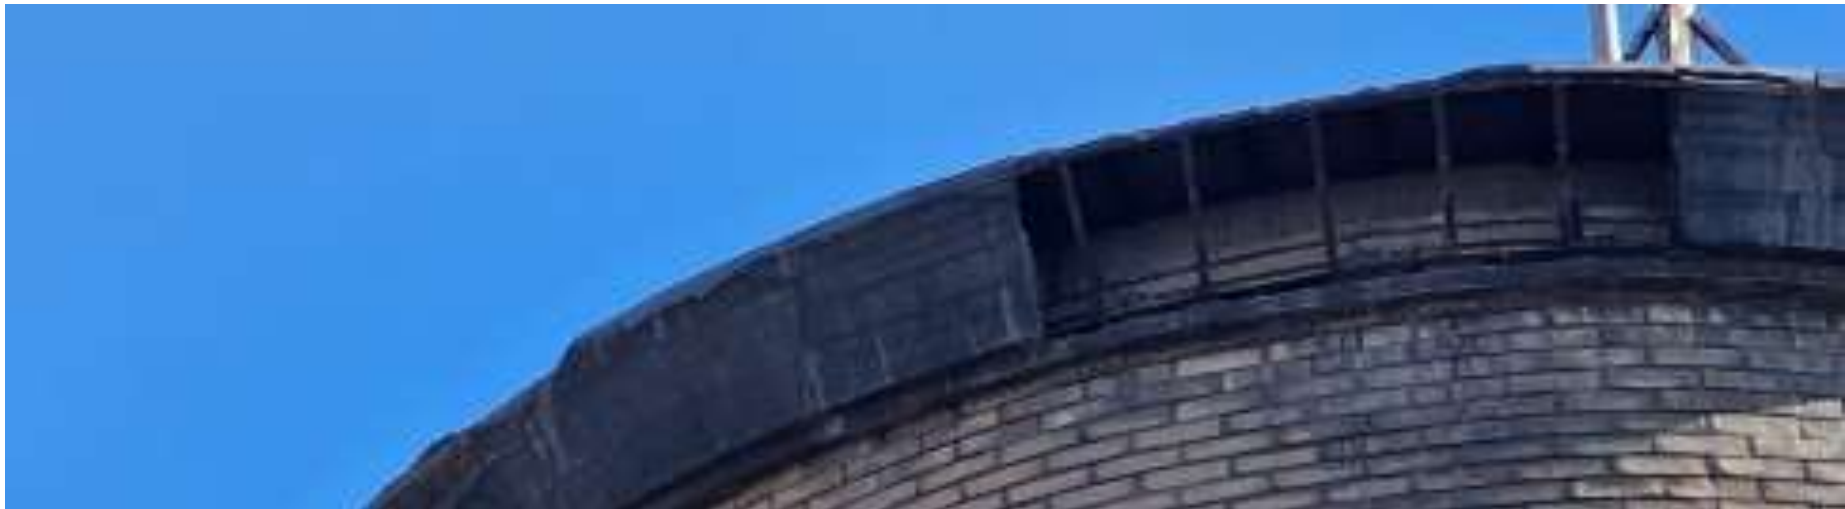
2-6- Parapet

The parapet was added most probably at the time of the brick facing at the late 1980s or early 1990s, the structure is a light weight angle iron, that supports a layer of galvanized metal hey rib, then the hey rib was rendered with cement plaster on top of it a very fine sand and cement mixture layer was added to look like a very smooth fair face cement

Many defects in the cement layer were detected, it is almost completely damaged it was noticed the angle iron layer is less damaged, only few members were affected by corrosion, it is suggested to remove the hey rib and cement layer, maintain the structure, fix a new layer of hey rib then render it with cement mortar and add the final smooth surface cement that is called locally (TALLES), asking the people on site they advised that skilled craftsmanship for this task still can be found in Baghdad

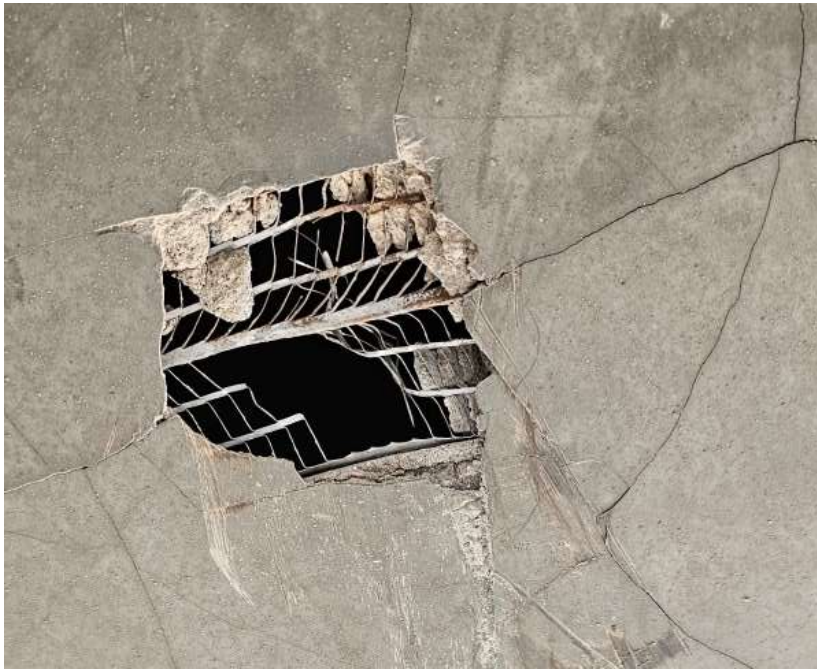
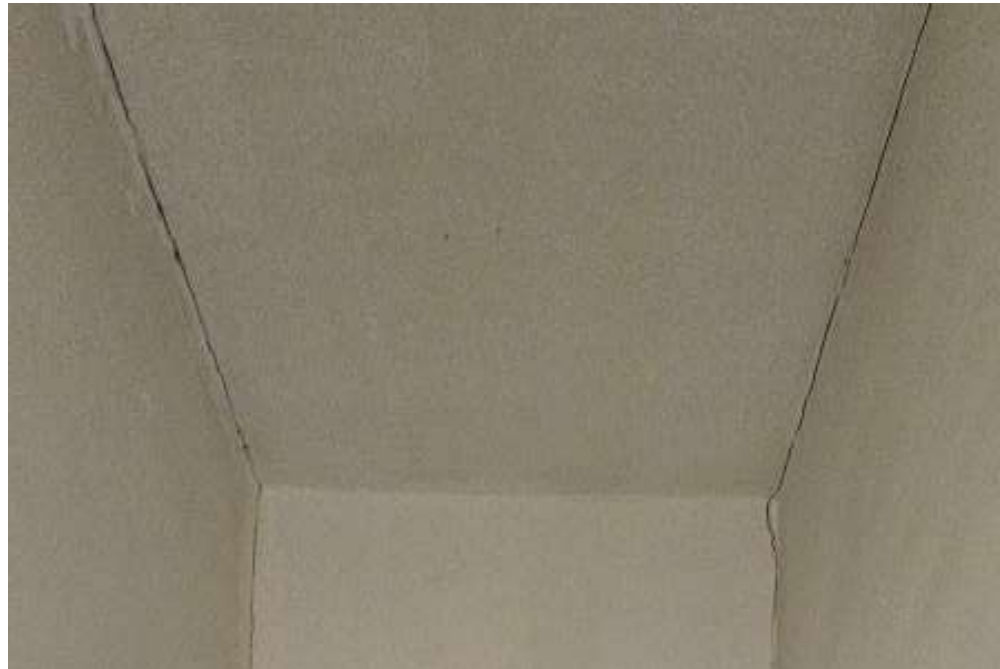
2-7- False ceiling

There are no noticed damages in the false ceiling, except for one location at the right side corridor in the ground floor that can be easily maintained, the major concern is that of the termite, it is assumed that this void between the slab and the false ceiling is used by the termite, it is recommended that a retarded (at least for 6 months effect) anti termite chemical to be sprayed. In case it was decided to use the void between the false ceiling and the slab for serviced (AC pipes, water supply pipes, sanitation pipes and electrical conduits, it is recommended to create inspection opening
