Assessment report Historical Building Turkish Cultural center Wazeriyah – Baghdad – Iraq

Date of visit 26-1-2024

Prof. Dr. Mahmood Khayat

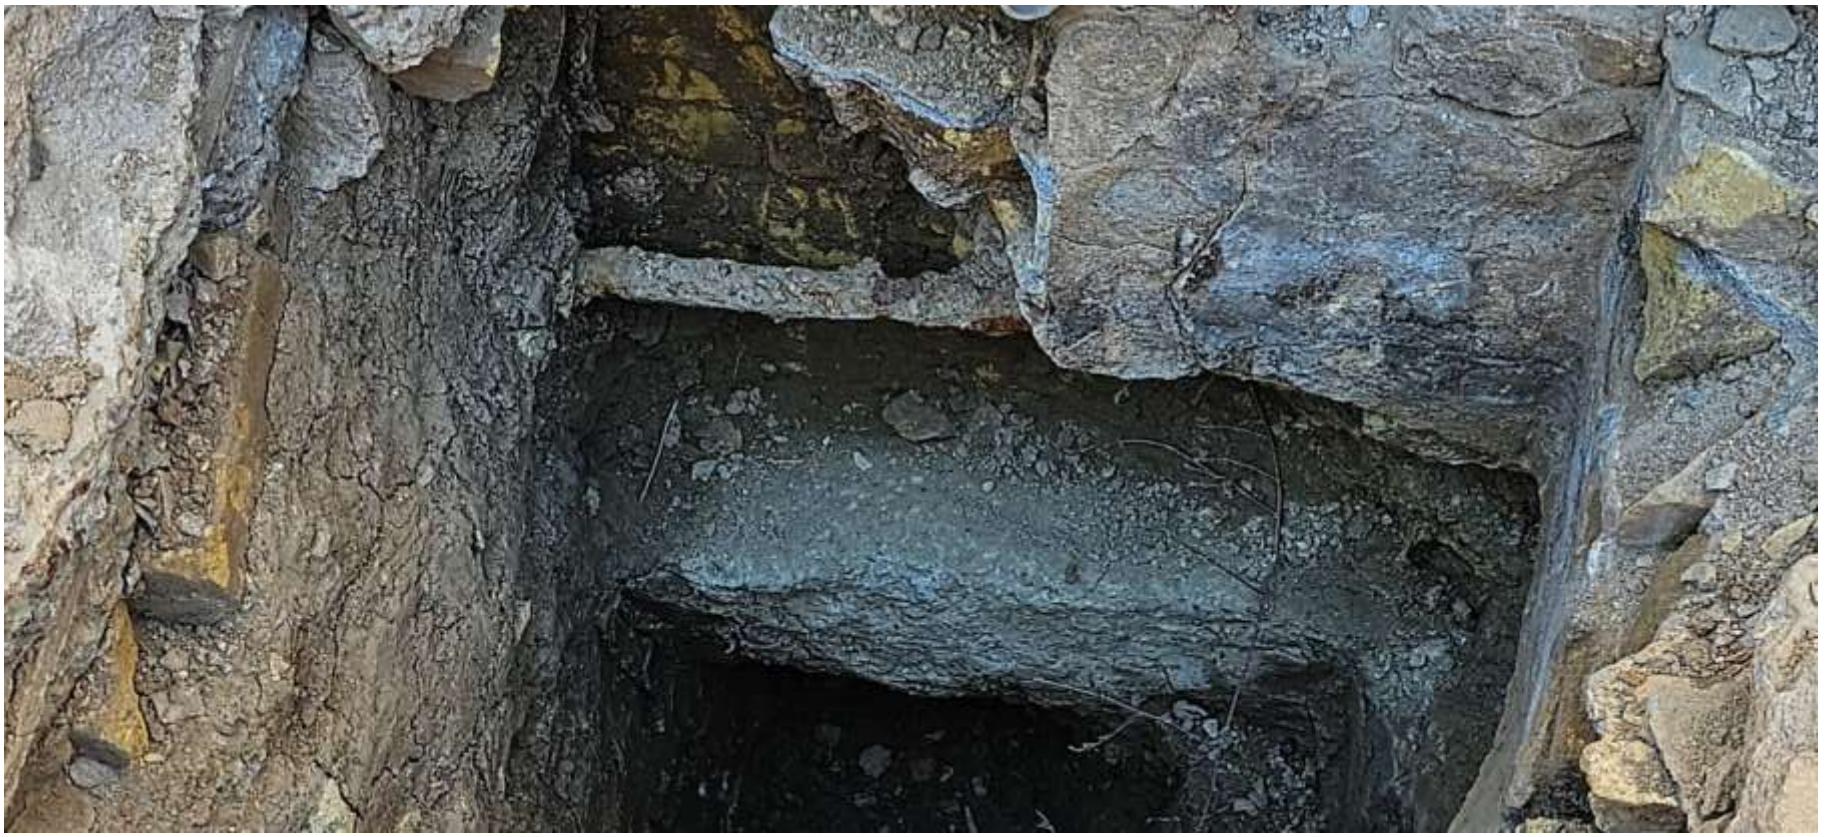
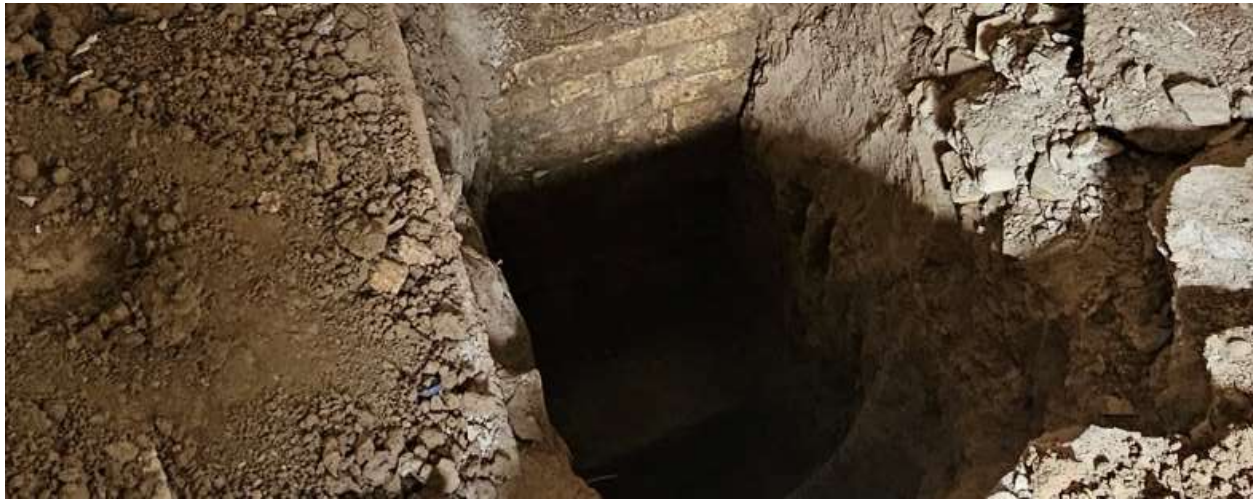
2-8- Foundation

The foundations can be detected from 3 views (the 2 inspection pits and the wall at the rare garage no serious cracks were detected neither vertical that indicates loading failure nor horizontal that indicates soil failure, and differential settlement, there are some minor non continuous hair cracks that are common in masonry, the major issue that needs especial care is the raise of ground water in the exposed areas like the garage wall were the effect of salts movement is clear and the efflorescence phenomenon is very clear, this can be treated or prevented by letting wet parts of the structure stay wet and the dry parts stay dry, the additional brick facade facing foundation walls functioned very well to prevent the structure walls from peeling that may cause damages for the structure as it is very clear in the garage near the ground and beneath damp proof course.

It is recommended to construct a (10-15cm) concrete wall to cover the lower part of the wall beneath the damp proof course.

It is recommended the balance of the soil beneath the foundation not be disturbed in order to maintain the balance of load distribution, in case there is a need for any type of continuous trenches that goes parallel to the wall of the structure to be a way of the walls at least twice the depth of the foundations in the case of this structure it should be more 3 m away from the wall.

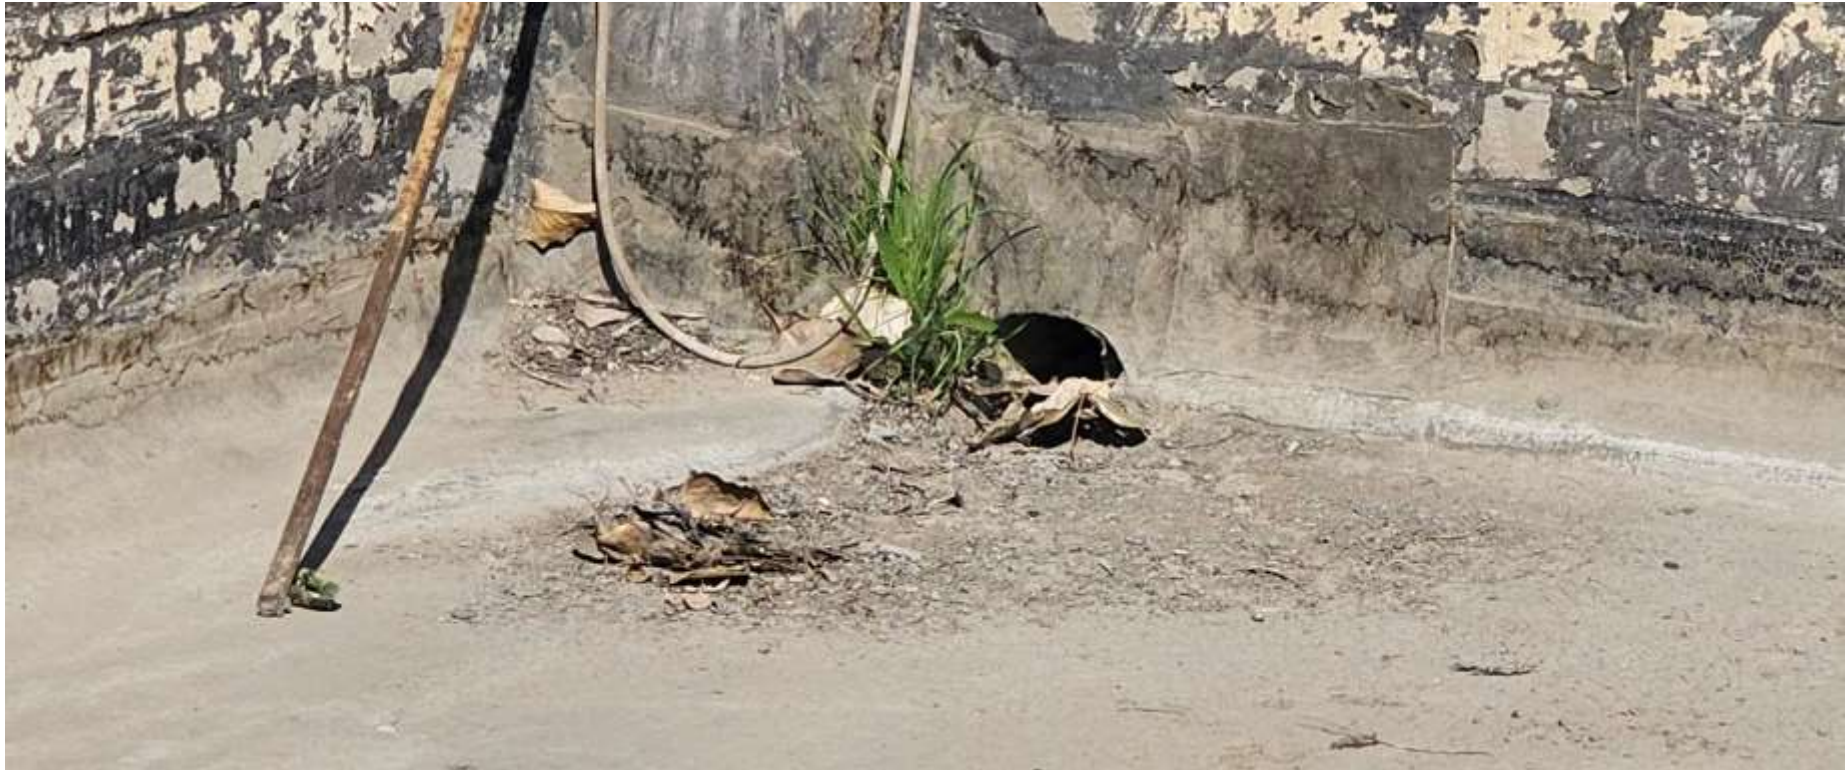
2-9- Roofing system

The roofing system looks OK from outside and the slopes looks function and takes the water to storm water to the storm water pipes, and the bituminous sealant is recently maintained, but it is not clear whether there is any water gathered beneath, it is recommended to create an inspection opening by breaking one of the tiles and check whether the leveling sand is dry or wet or saturated in that case the right recommendations can be given but for sure there is no serious defect, and it can be easily maintained
