Assessment report Historical Building Turkish Cultural center Wazeriyah – Baghdad – Iraq

Date of visit 26-1-2024

Prof. Dr. Mahmood Khayat

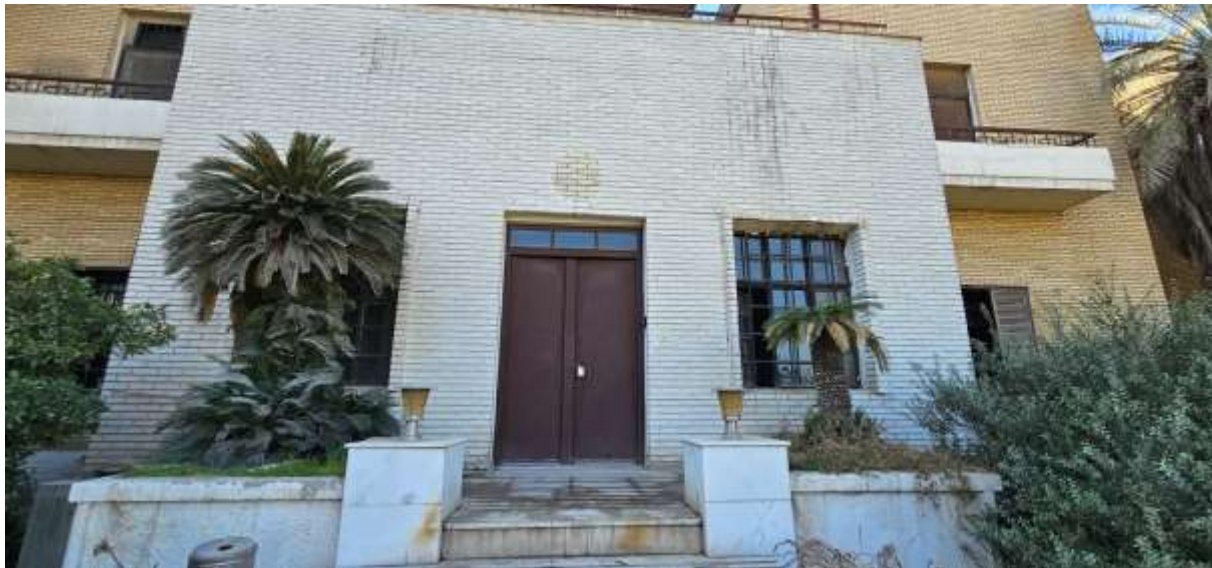
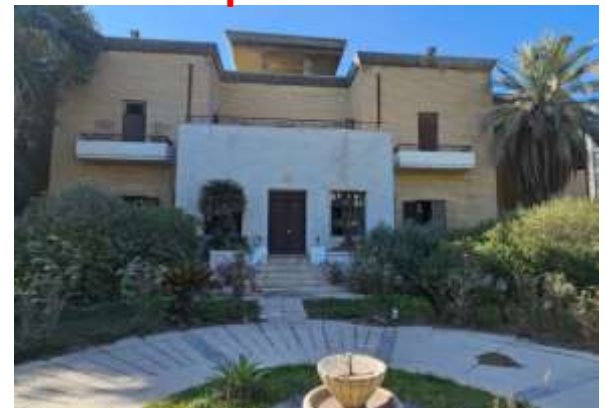
The entrance is raised by 3 steps, these steps are made of Turkish Marble, mostly Diyarbakir or Mugla beige, the flower beds are covered with Gray White Turkish marble most probably Afyon it is clear that the marble was added in the late 1980s or later because the traces of corrosion of the steel clamps are clear as orange stain on the face of the marble.

It is recommended to use:
Water jet wash
No grinding
Same color paint

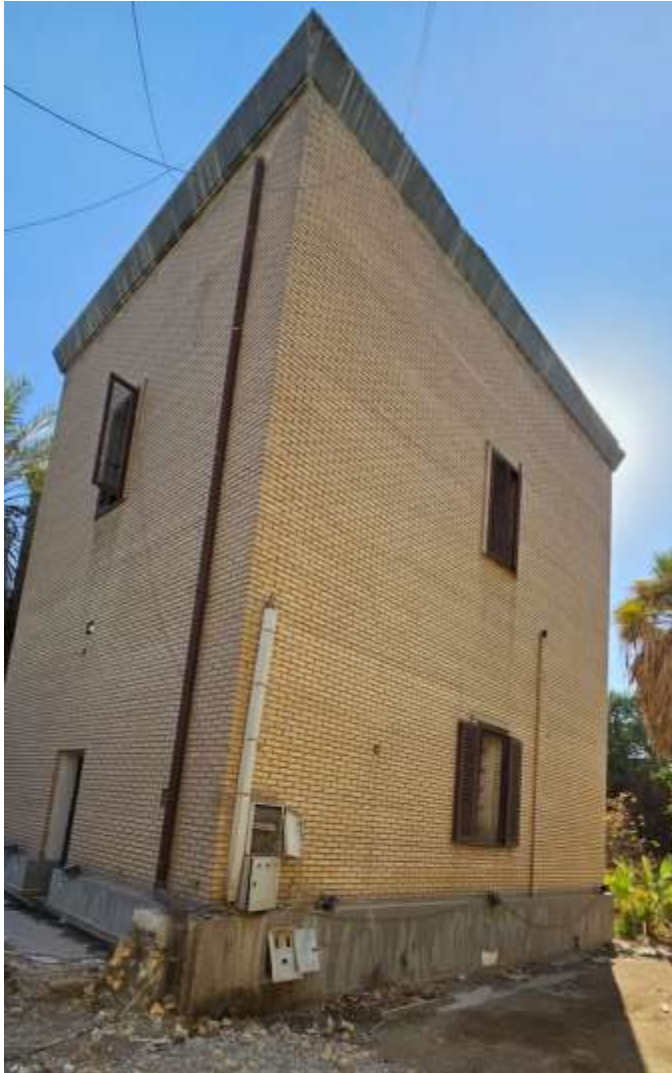
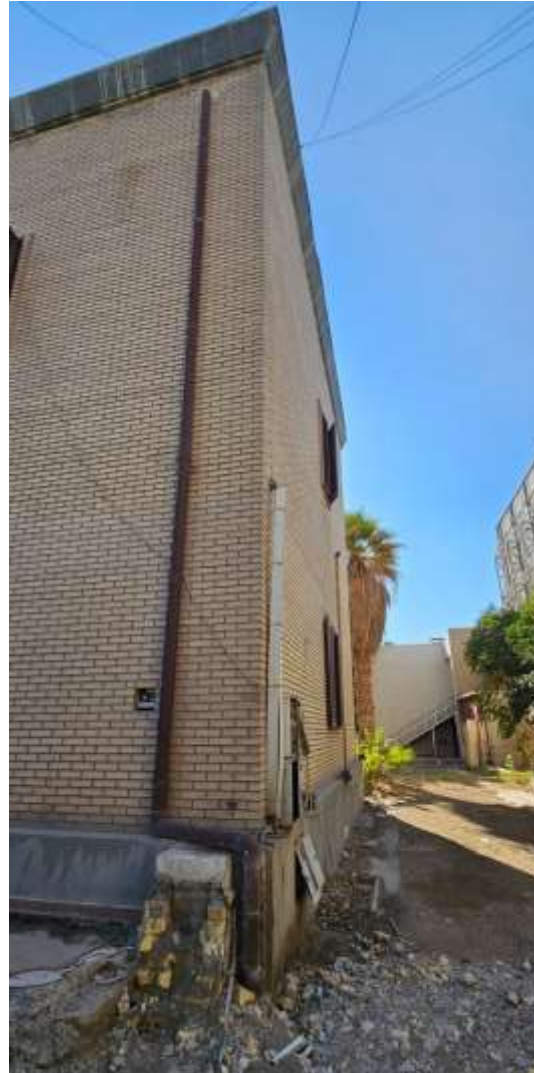
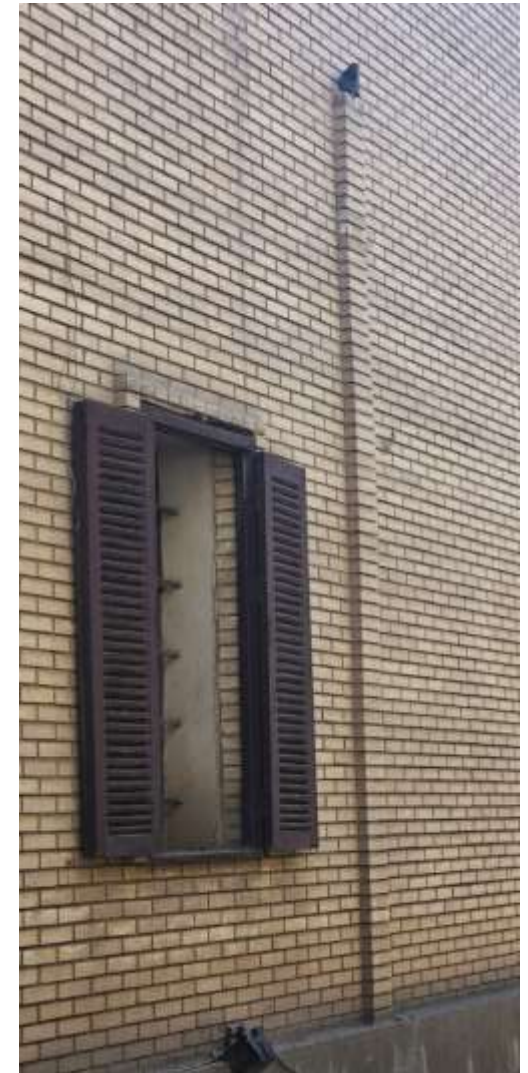
1-1-2- Façade 2

The side façade 2 is a high blank wall with few openings some new steel and plastic pipes can be noticed it is clear they were added later after the facing period, the old pipes before the time of facing with brick were covered by brick, and they can be noticed as vertical stacks on the façade

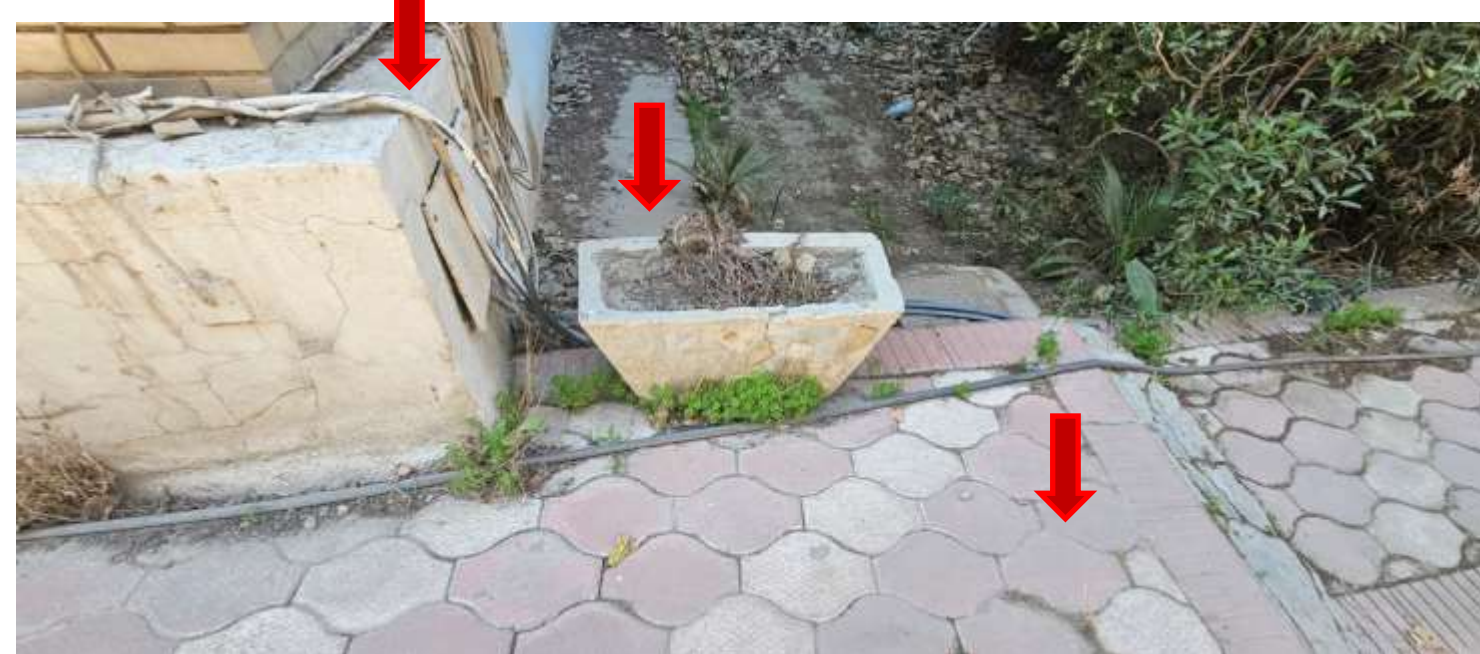
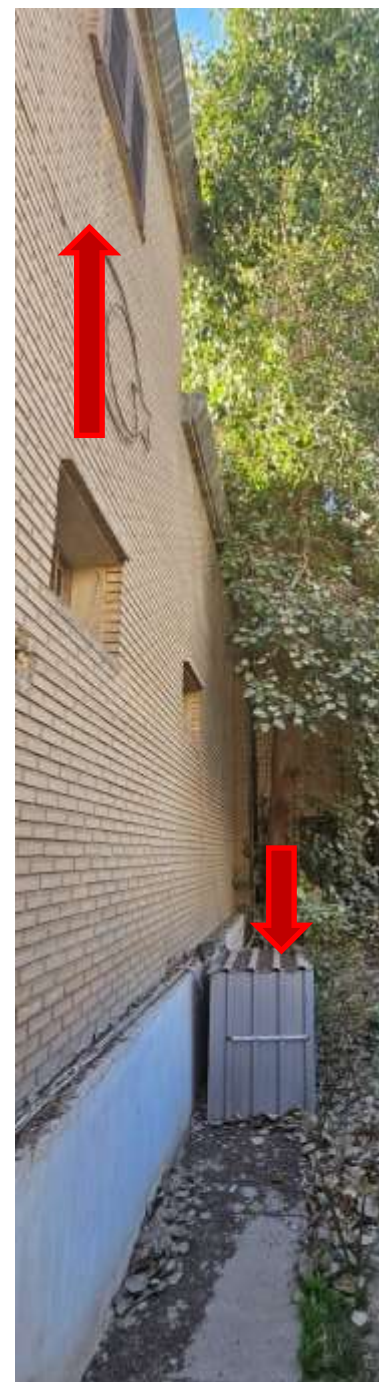
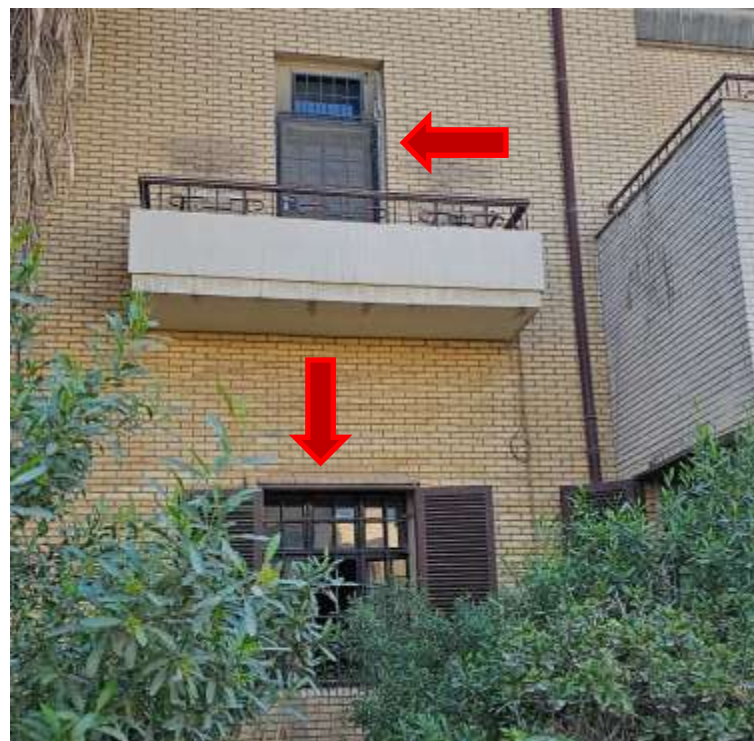
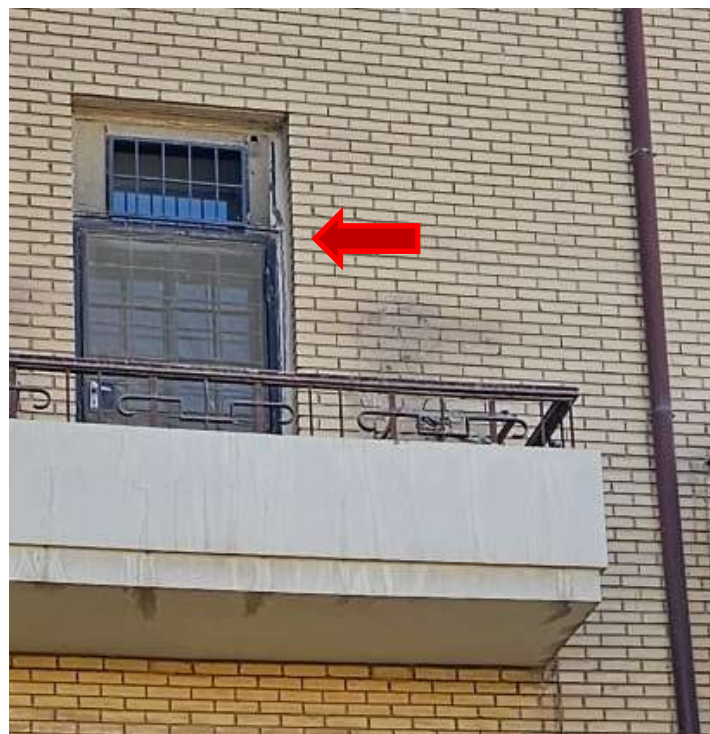
1-1-4-Façade 4

Façade number 4 covers the side facade of the main building and what can be seen is a high wall of a separated structure of the garage and the service area and the kitchen, a vertical hair crack can be noticed in the brick facing wall.

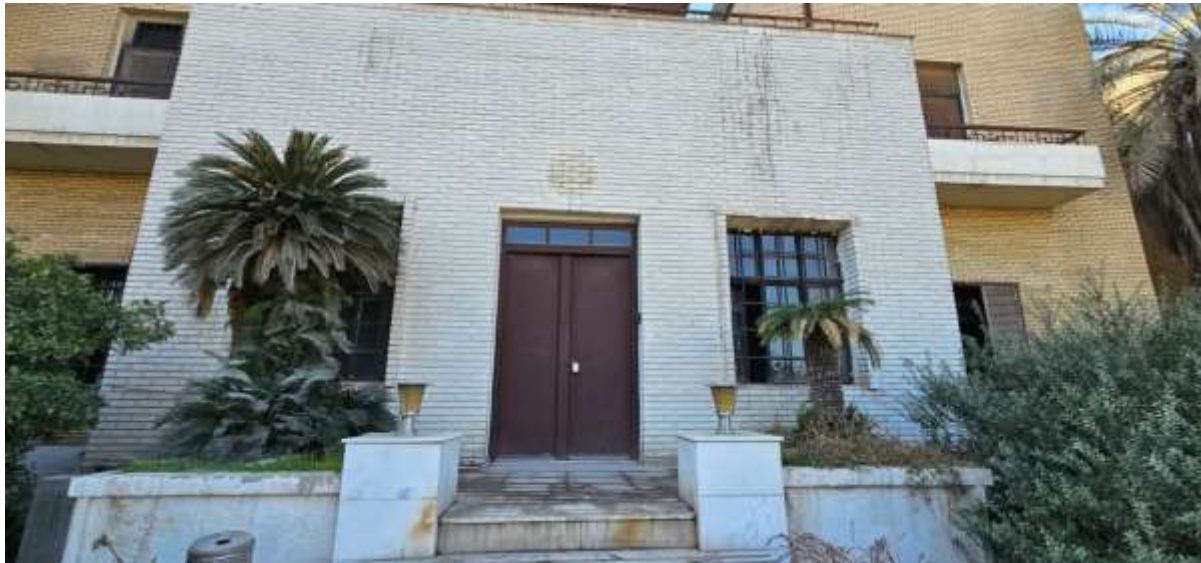
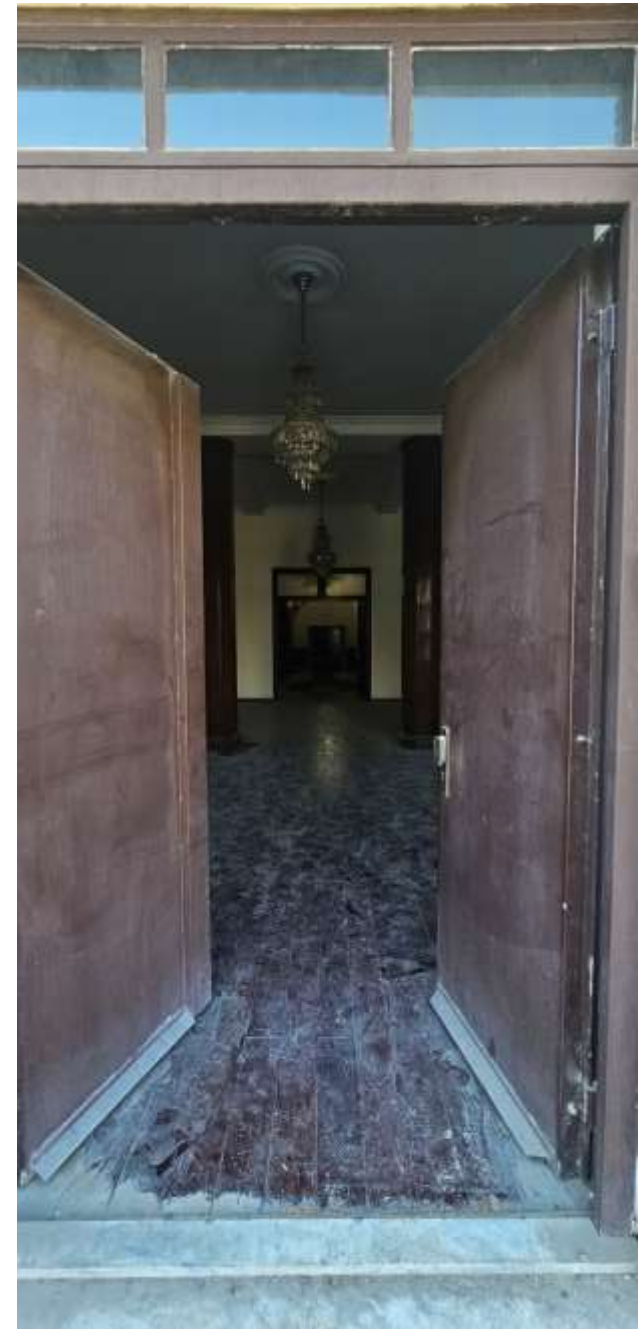
The interior layout of the house reflects the symmetrical of the 1940s house design approach in Baghdad, some features like the fire places, chandeliers, doors design, steel windows and the use of teak wood for some of the doors and the stair case refers to that era, but also traces of many modifications, changes and maintenance works can be noticed especially flooring tiles it is all new porcelain tiles, in one case the original 20x20x2cm dark red cement tiles can be noticed, but it is damaged and in a bad condition.

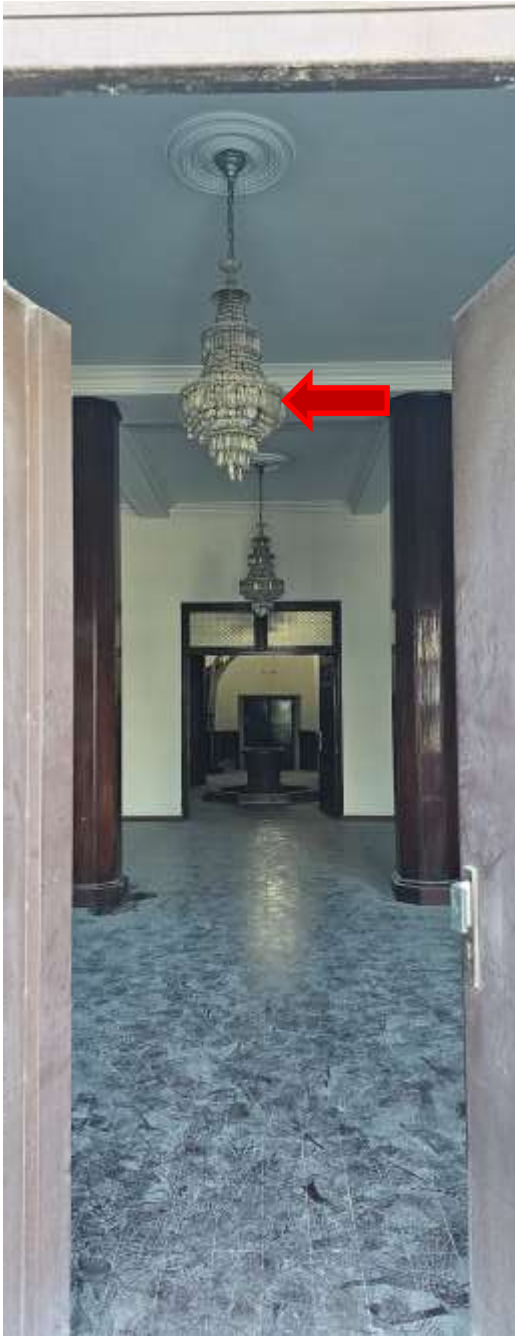
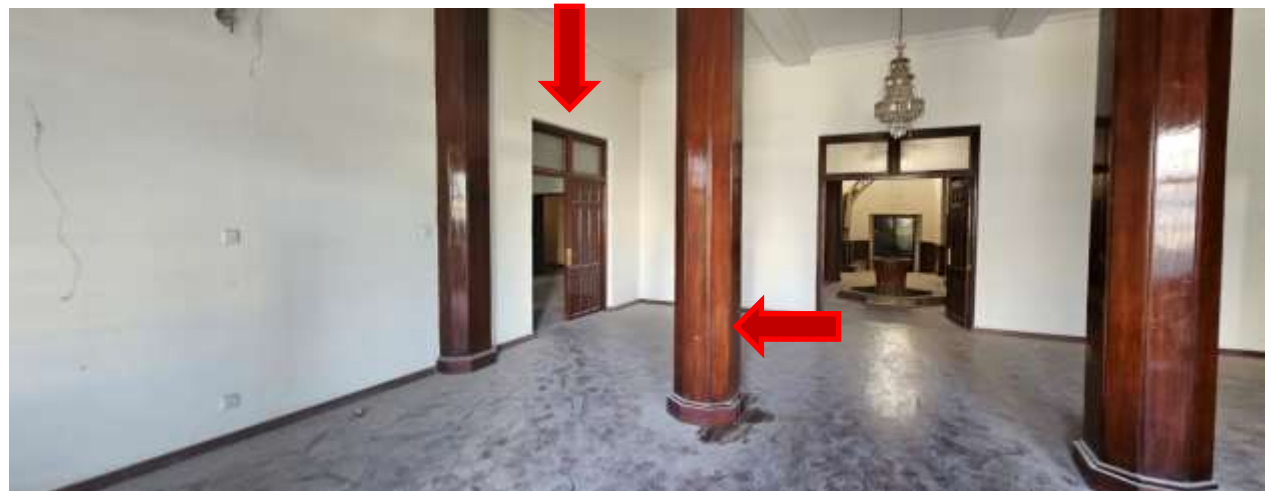
1-2-1- Ground floor

In the ground floor the symmetrical order is broken by the link with the services wing, it is clear that this wing was added in later stages, the ceiling is covered by false ceiling made of metal Hey rib and covered by gypsum which was common at the time of construction of the structure, the termite traces are clear on the walls, the fire places are at their original locations but the cover is modified during various stages, the existing 2 chandeliers at the 2 large rooms on the left and right side of the entrance hall dates back to the 1950s the other lighting fixtures are changed and dates to various times, there are traces of cracks at the right side corridor, these crack are not serious

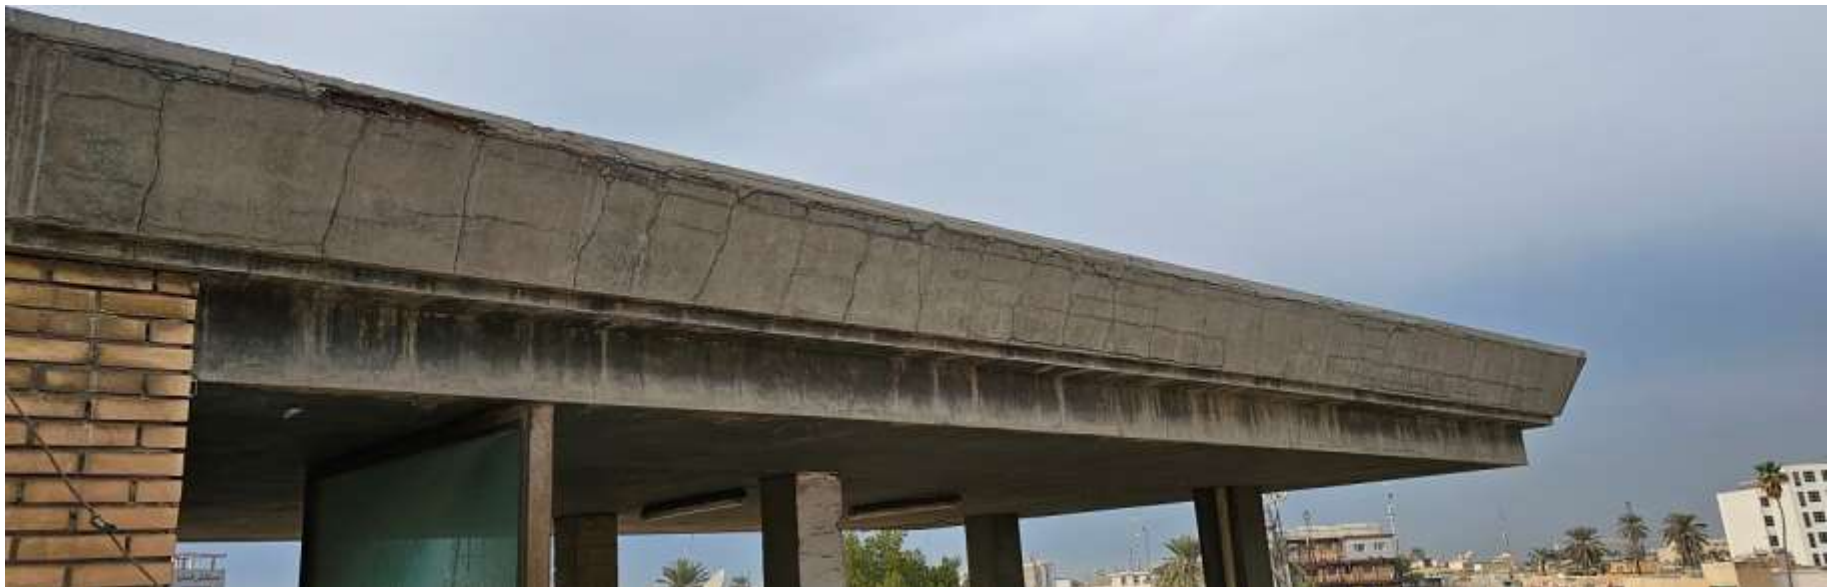
The penthouse is small form the inside, the structural system is very clear because there is no false ceiling, the traces of the I beams are very clear, from the outside the roof is extended forming a shaded area, from the outside there is a hey rib false ceiling covering the structure but this one is finished with a very smooth cement rendering that was common in the late 1980s.

The roofing system is made from 80x80x4cm concrete slabs it is called locally (STAIGER) , this roofing system became common at the late 1950s and early 1960s, and it is clear that there was a replacement for the roofing tiling and the slopes were changed even after the facing of the façade with brick work, the old cast iron storm water pipes are covered with brick while there are exposed PVC pipes
No traces for damp can be seen from inside because of the false ceiling

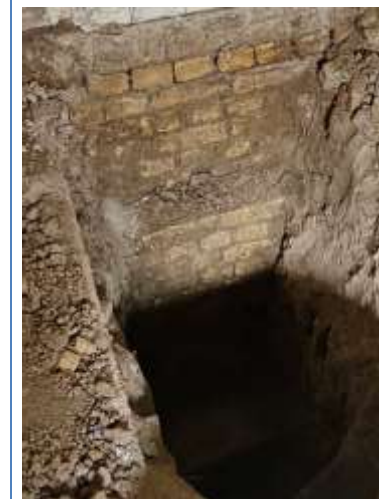
The foundation is a strip type with staggered brickwork base until reaching the width of 48cm which is the width of the walls, at one of the inspection pits a concrete damp proof course can be noticed, this layer is called locally (PADLO), it is a plain concrete layer where sulfates salts resistant cement is used in addition to adding porosity reduction agent (called locally SIKA) in the other pit, this layer was not was not visible, in other walls where the interior layer was stripped of the use of 2 types of brick was noticed the yellow (backed clay) brick and a grey one (most probably sand brick which was available at the time of construction, this type of brick is known for determining damp movement within the structure .

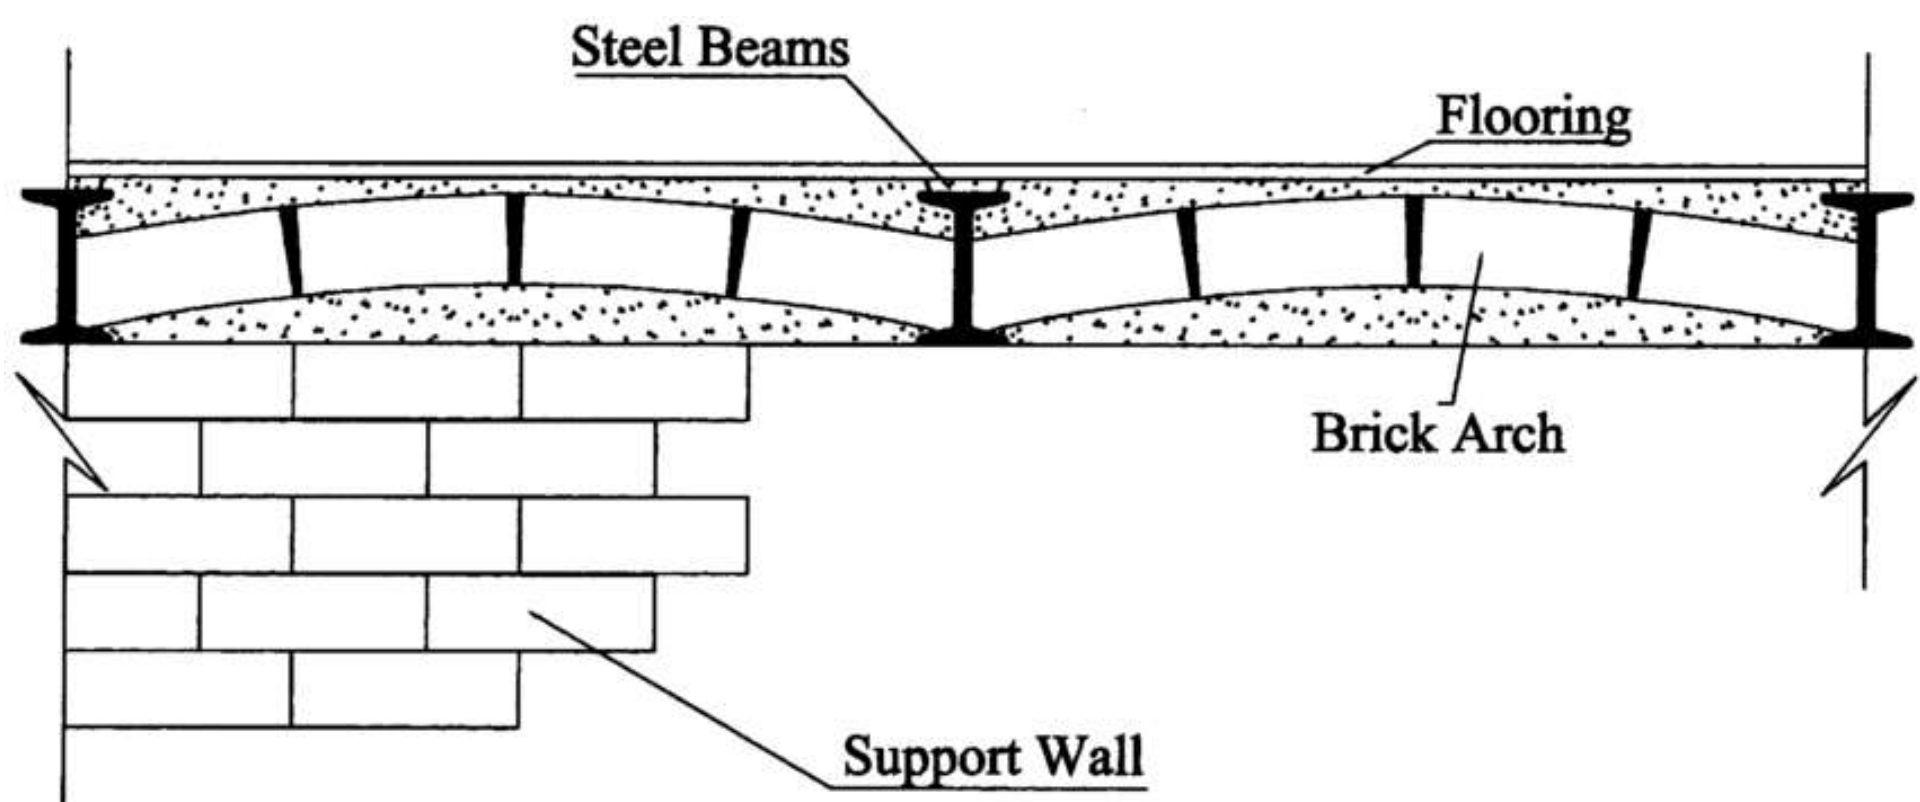
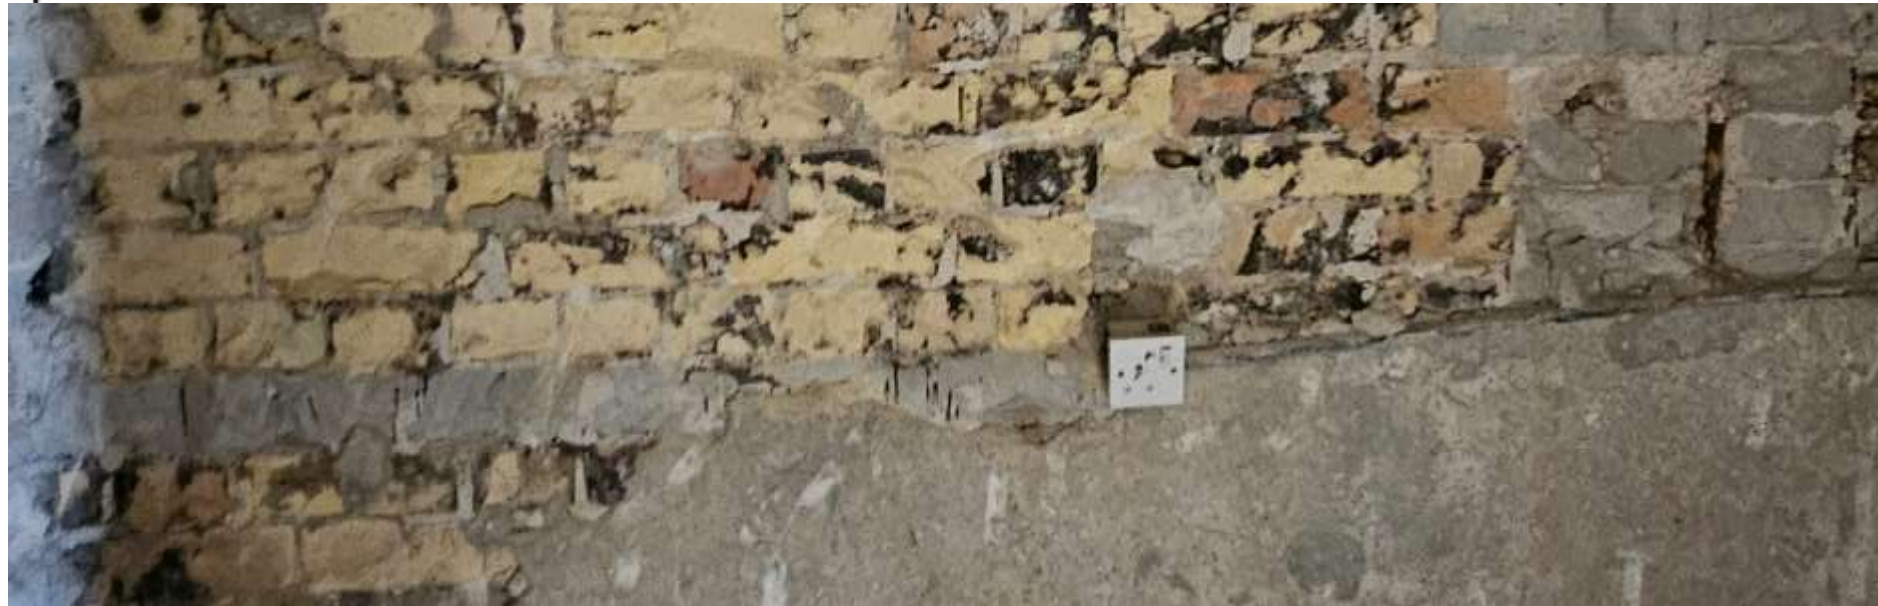
Slabs are made by using jack arching system using common brick, local gypsum, and steel I section beams it is very common to notice some cracks in such a masonry roofing system due to expansion and contraction and also the traces of the I beams may be very clear on the plaster finish as it is noticed looking at the pent house slab even it is casual to notice some cracks in the ceiling plaster finish and the walls especially parallel to the I beams, to cover the traces of these phenomenon in such structure especially in luxury structures it was common to use a false ceiling using metal hey rib and gypsum plaster finish it was used to called (SAKF BAGHDADI), no serious defects were detected because the slabs are fully covered by false ceiling.

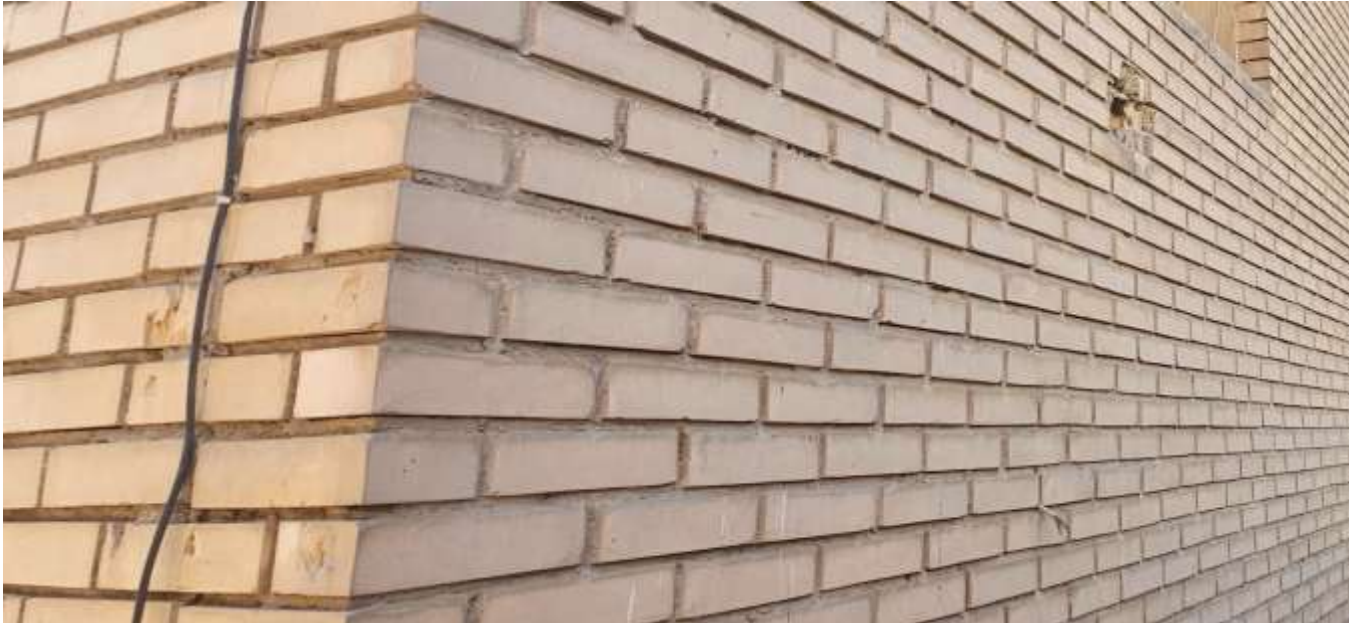
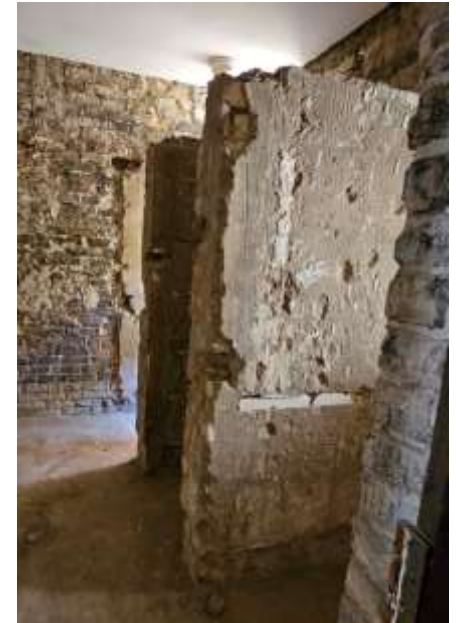
Some partitions (none load bearing) can be noticed in the structure especially in the wet areas and the service areas where multiple changes and additions in various stages can be noticed, it highly recommended to detect these areas carefully because jack arching slab system steel I beams may face some corrosion cases taking into consideration that gypsum is the mortar material that can itself be affected by damp or water, or may enhance corrosion when the gypsum catches water.

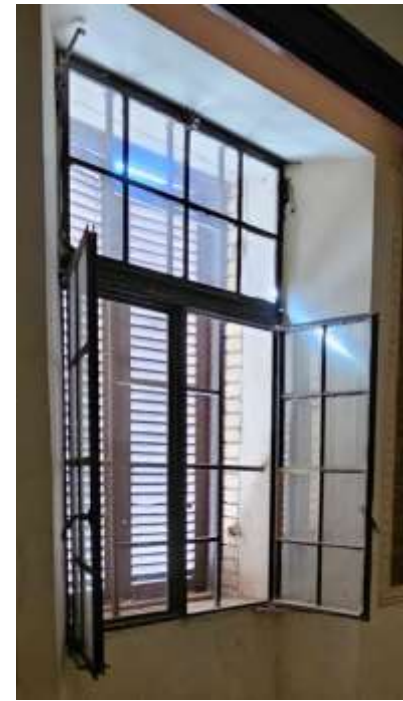
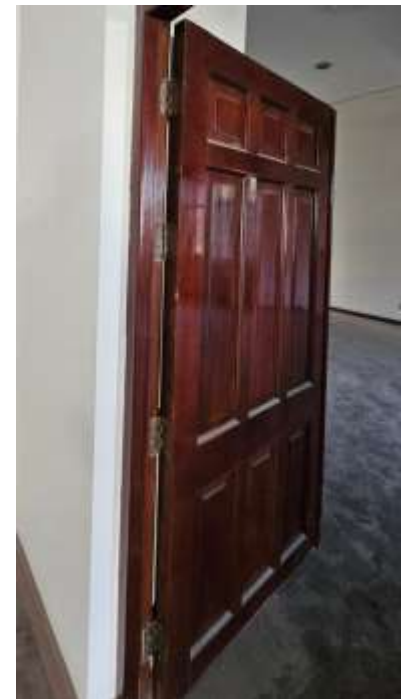
Internal doors are made of timber (wood) there are 3 types of doors, the first type is the old hard wood (teak wood) that needs to be preserved, the second type is old soft wood doors mainly they were used at the side rooms, they are severely damaged by termite or damp because they were used in wet areas, the third type are the ones added in later stages they are made of soft wood but colored to look like teak, they need to be replaced, while the external doors are made of steel especially the balcony doors they are made of old window section and glass and need to be well preserved, while exit doors especially in the ground floor they are added later, they can be kept and maintained or replaced.

All windows are made of steel using old steel window section, the central part windows for both floors are the old original ones that needs to be maintained and some sealing details to be used, while the windows of the service wing have the same look of the original ones but there are some missing details that are used in the windows of the central area

Wooden shutters do exist on most of the windows, some of them are damaged and others are missing, it needs to be well maintained and the missing ones be replaced

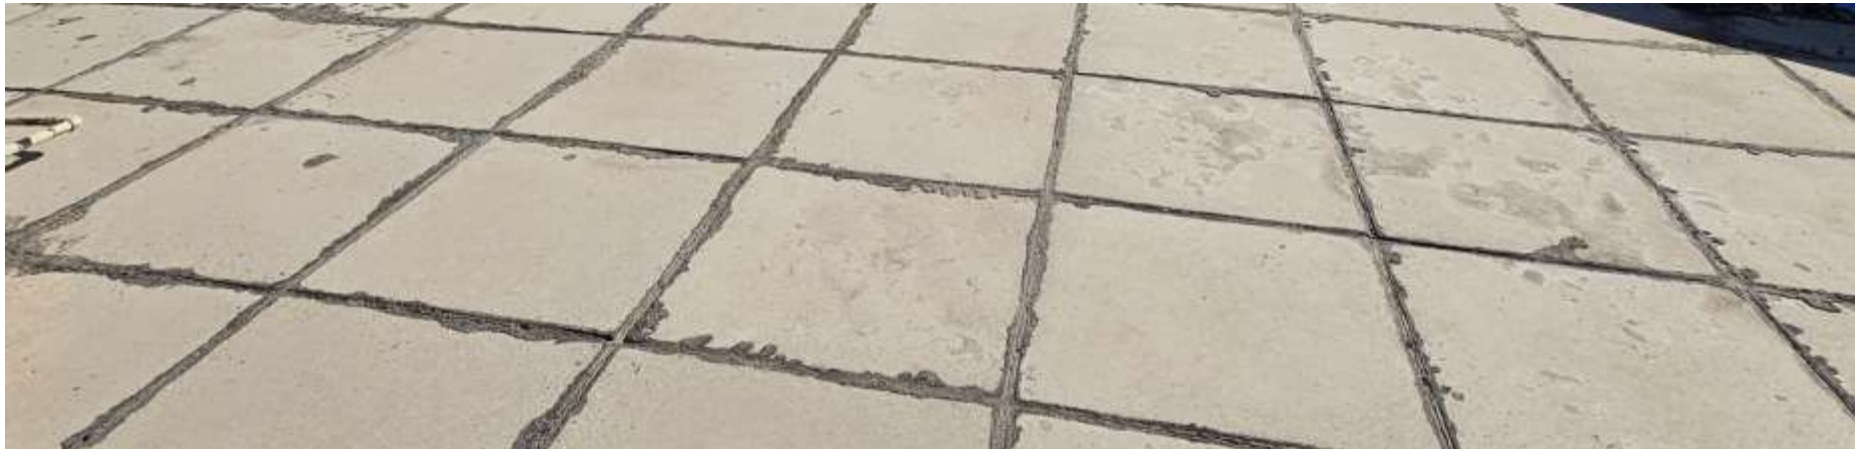
The roofing system is made from 80x80x4cm concrete slabs it is called locally (STAIGER) , this roofing system became common at the late 1950s and early 1960s, these tiles are the final layer, beneath it there additional layers it may vary from case to case, basically the jack arching slab is covered by a layer of bituminous felt then layer of hard bitumen that acts as a damp proofing layer, on top of it a sloping layer is added which can be (5-15 cm) sand or fine sand and earth mixture the slopes are 1 % towards the storm water drainage pipes, on top of it the layer of the 80x80x4 cm concrete tiles are laid as per the slopes, the joints are filled with bituminous sealant (locally called MASTIK), it is clear that the roofing system was maintained many times and the slopes were changed, and plastic drainage pipes were added, no serious defect was noticed from inside. The inside false ceiling did not show any damp or water traces, but this does not mean that the brick and gypsum mortar of the jack arching slab is not wet and has not cached water.

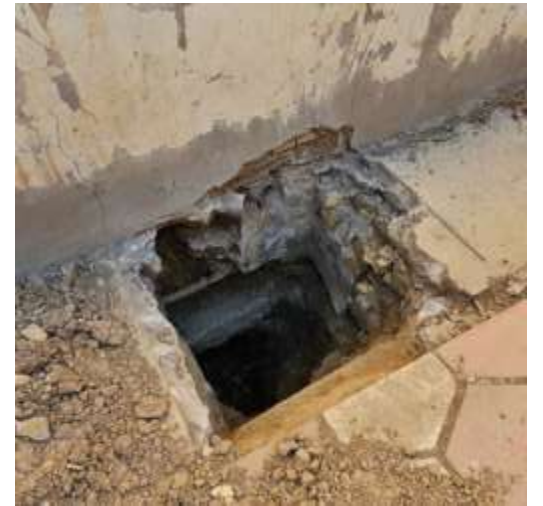
The foundations can be detected from 3 views (the 2 inspection pits and the wall at the rare garage no serious cracks were detected neither vertical that indicates loading failure nor horizontal that indicates soil failure, and differential settlement, there are some minor non continuous hair cracks that are common in masonry, the major issue that needs especial care is the raise of ground water in the exposed areas like the garage wall were the effect of salts movement is clear and the efflorescence phenomenon is very clear, this can be treated or prevented by letting wet parts of the structure stay wet and the dry parts stay dry, the additional brick facade facing foundation walls functioned very well to prevent the structure walls from peeling that may cause damages for the structure as it is very clear in the garage near the ground and beneath damp proof course.

It is recommended to construct a (10-15cm) concrete wall to cover the lower part of the wall beneath the damp proof course.

It is recommended the balance of the soil beneath the foundation not be disturbed in order to maintain the balance of load distribution, in case there is a need for any type of continuous trenches that goes parallel to the wall of the structure to be a way of the walls at least twice the depth of the foundations in the case of this structure it should be more 3 m away from the wall.
